NATURAL AND ARTIFICIAL INFLUENCES ON COASTAL EROSION AT SIDMOUTH, DEVON, UK

R. W. GALLOIS

Gallois, R.W. 2011. Natural and artificial influences on coastal erosion at Sidmouth, Devon, UK. *Geoscience in South-West England*, **12**, 304-312.

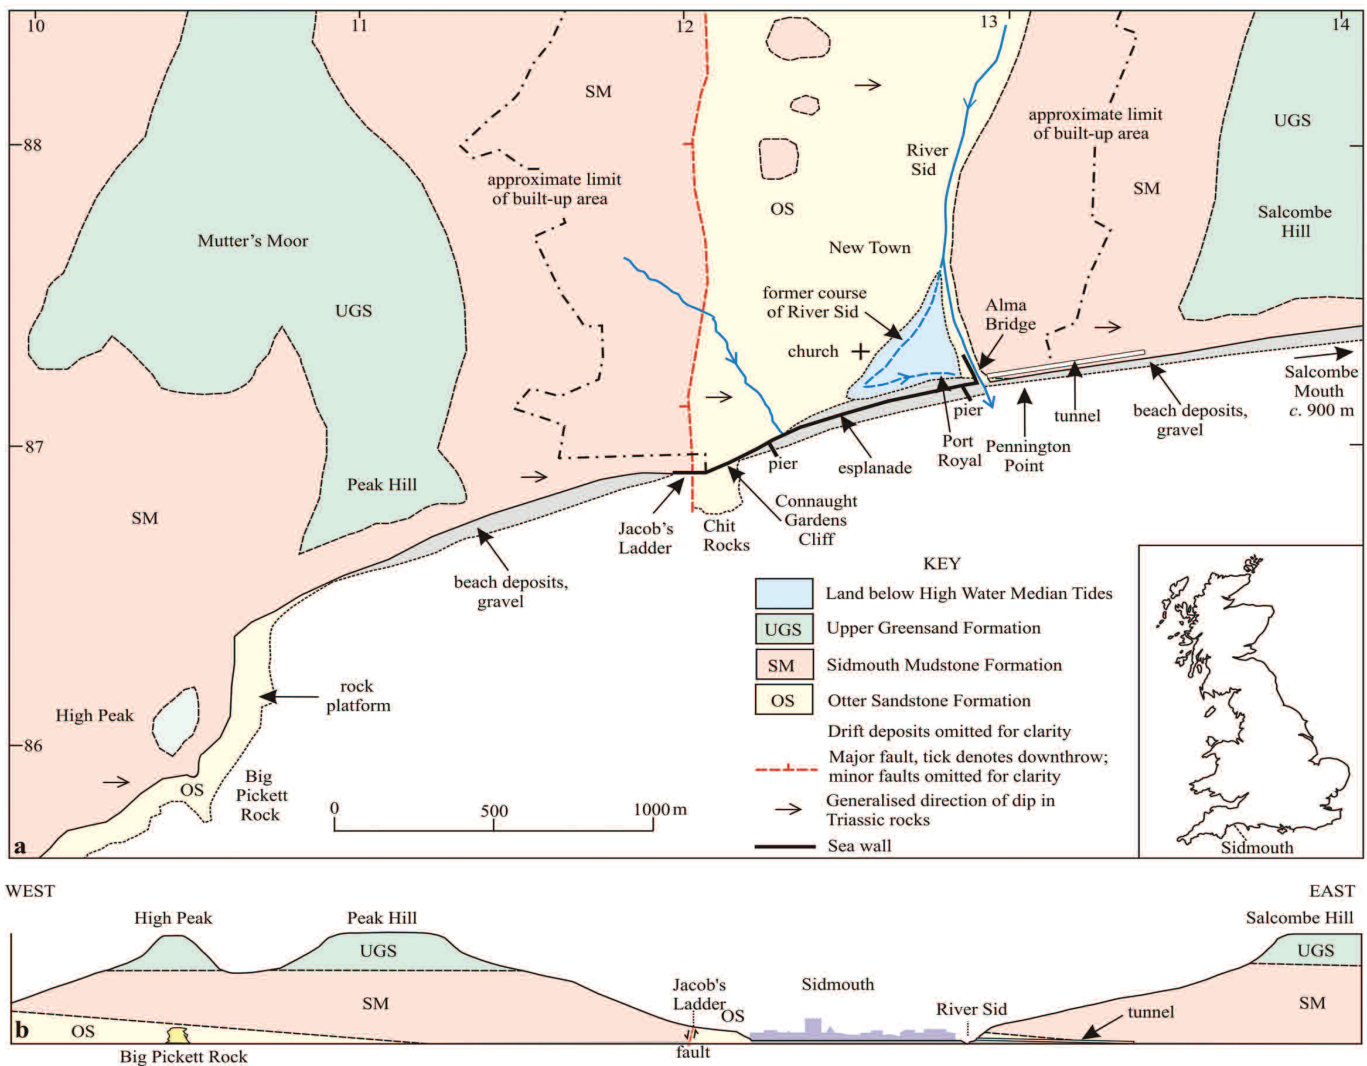
Figure 1. (a) Geological sketch map of Sidmouth and the adjacent area showing the positions of location referred to in the text. Geological boundaries based on British Geological Survey 1:50,000 Series Sheet 326 (Sidmouth). (b) Geological sketch section approximately parallel to the coast. Vertical exaggeration c. 2x.

Sidmouth experienced a period of rapid expansion in the mid 18th Century when the River Sid was diverted to run in an artificial channel at the foot of a rock face cut into the Otter Sandstone on the east side of the valley (Figure 1). The earliest detailed map of the area (Donn, 1765) shows the river in its present position, and some of the low-lying marshland on the landward side of the beach ridge as a built-up area. This included the area now occupied by Old Fore Street, Fore Street and Market Square. The town became popular as a genteel coastal resort in the late 18th Century with the result that houses

In 1836 the Sidmouth Harbour Company obtained an Act of Parliament to construct a harbour at the western end of the town with a breakwater founded on the Otter Sandstone at Chit Rocks (Figure 1). The stone for the harbour walls was to be obtained from the Upper Greensand Formation (Salcombe Stone) at Salcombe Regis, 2.6 km ENE of Sidmouth, and brought to the site on a railway that ran along the beach from Salcombe Mouth [SY 145 877]. Part of the railway was completed in 1837, but this was destroyed during storms during the following winter (Messenger, 1974). A new railway was constructed with the most vulnerable part of the route in a tunnel that ran from the east bank of the River Sid downstream from the Alma Bridge (Figure 3c) to the top of the storm beach c. 540 m to the east. The tunnel, 2.0 m high and 2.3 m wide, was excavated in the top part of the Otter Sandstone Formation and the lowest part of the Sidmouth Mudstone Formation, up to 25 m inland from the cliff face (Figure 1). It was designed for use with a steam engine that was being built at the Abbey Ironworks at Neath, formerly West Glamorgan (Perkin, 2009). When it arrived, the engine was too large for the tunnel (Hutchinson, 1857), and although a smaller engine was made and attempts were made to revive the harbour project, none of them succeeded.

The original Sedemude was sited in the sheltered embayment between two outcrops of Otter Sandstone Formation (Figure 1). On the west side of the town, the sandstones crop out in Connaught Gardens Cliff and the adjacent wave-cut rock platform. On the east side, where the sandstones crop out along the east bank of the River Sid and in the adjacent sea cliff, they form a series of offshore ledges that mark the site of the former Pennington Point. There have been few landslides in the Otter Sandstone on the west side of the

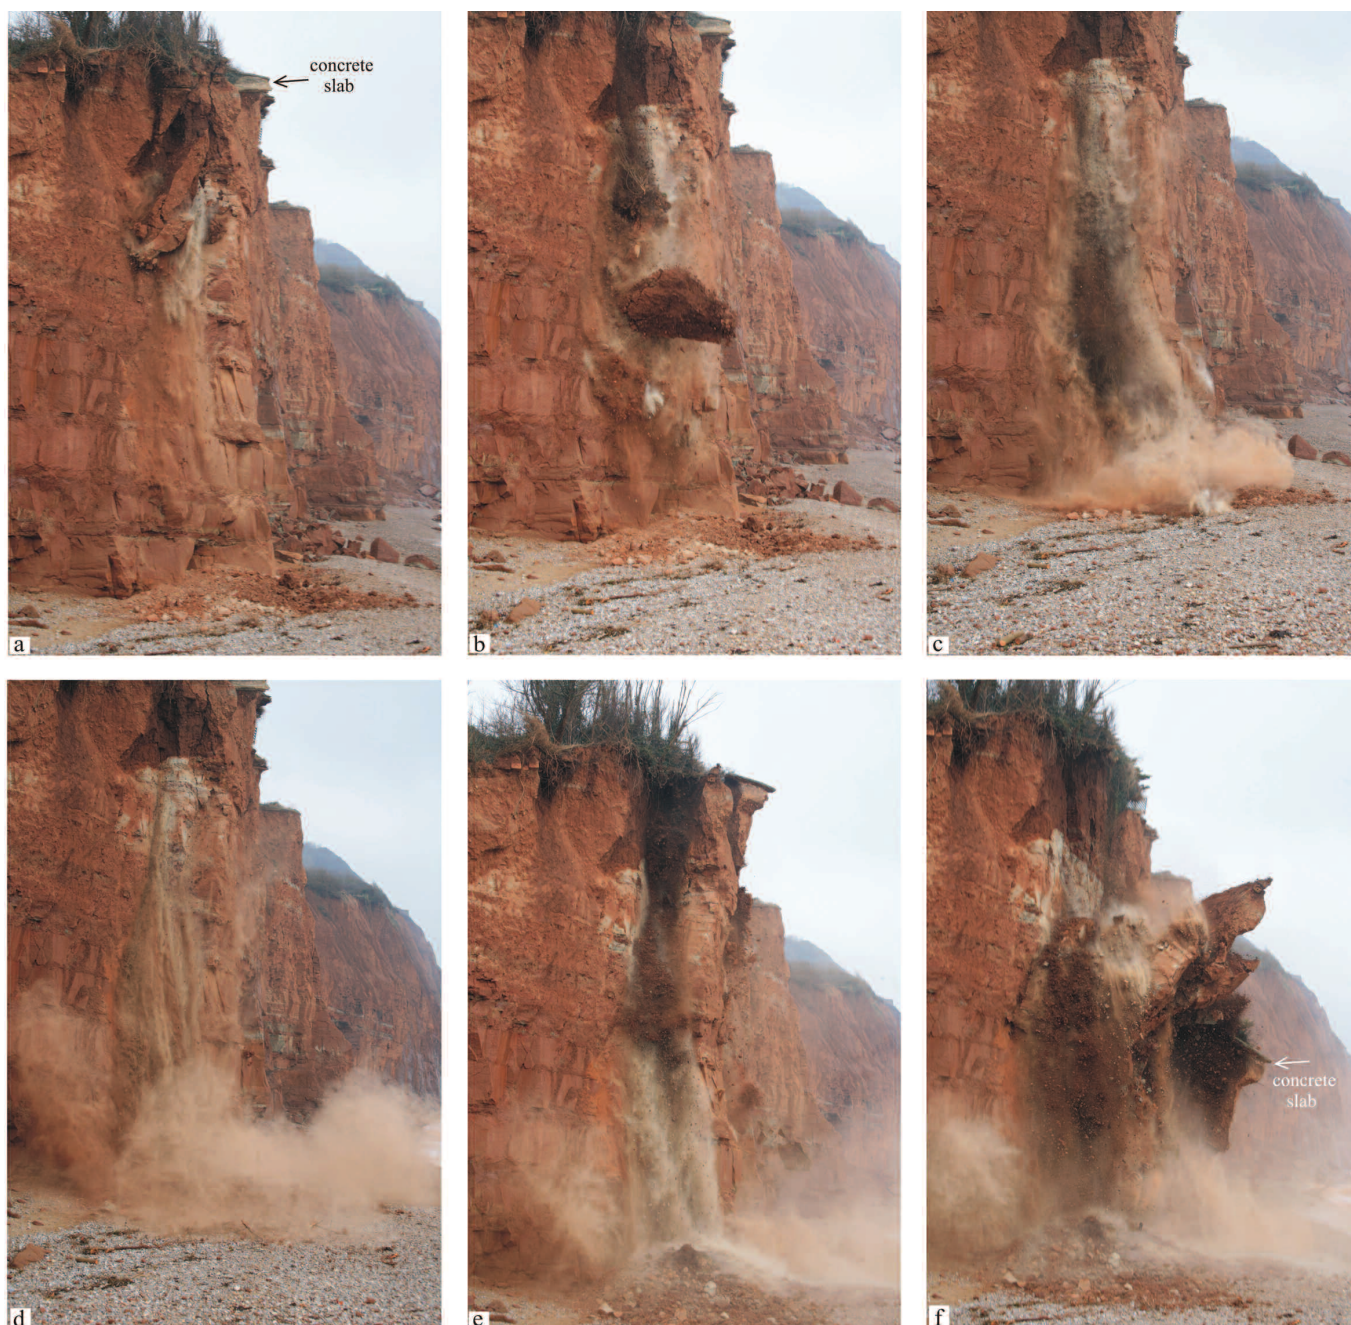
Figure 6. Landslide shown in Figure 5 photographed over a period of one minute by Eve Mathews. Small debris falls continued to occur over the next 10 minutes. Reproduced courtesy and copyright of Eve Mathews.

in the Pennington Point Member (Figures 5 and 6a). This dislodged some of the underlying sandstones and mudstones in the middle part of the cliff (Figures 6b to 6d), but the lower part of the cliff remained largely undisturbed. At the top of the cliff, the failure in the Head deposits and weathered mudstones progressed eastwards as a series of toppling failures and dislodgements (Figures 6e and 6f). This included a large concrete slab (a former viewing platform at the edge of the coastal path) that had been overhanging the beach for several years (Figure 6f). Debris and small blocks of material continued to fall from the cliff for ten minutes after the initial event. The same 'top-down' mechanism was inferred for a larger landslide (several thousand tonnes) that occurred in the Sidmouth Mudstone 420 m ENE of the river outfall in October 2001 (Gallois, 2001). In both examples, the well-jointed nature of the Triassic rocks in the middle and lower parts of the cliff was an important factor in their collapse.

adjacent to Pennington Point has retreated faster than the base, and some parts of the bottom and the top have experienced little or no movement. For example, the sandstones at the foot of the western end of the cliff have not been eroded during that time, and the concrete slab shown in Figure 6 projected out from the top of the cliff for at least 7 years before it fell in February 2009.

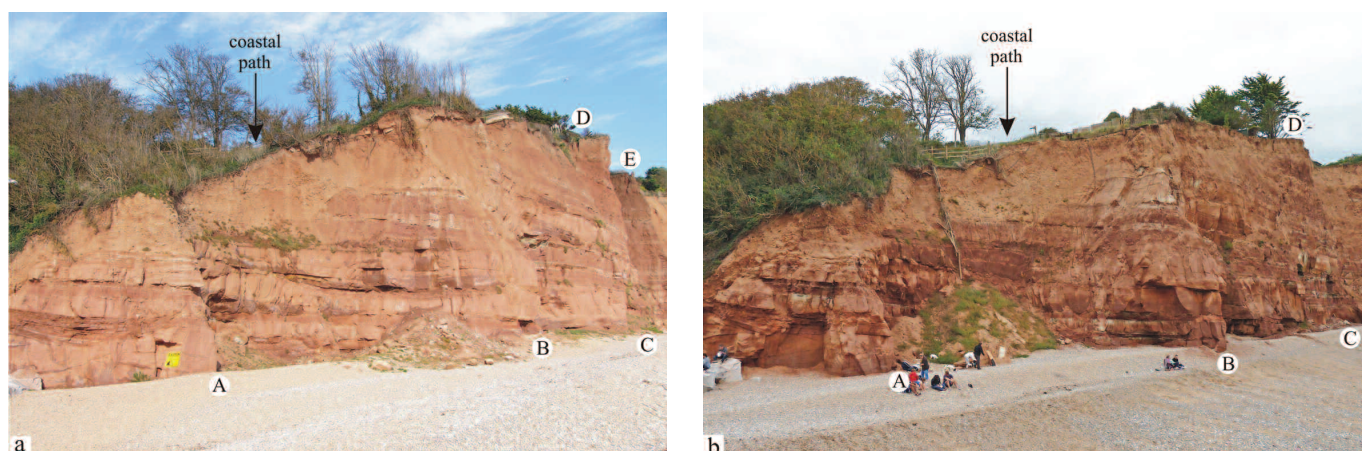
Figure 8. The western end of the cliff adjacent to the outfall of the River Sid at times of high beach level viewed from the river wall (a) 7th January 2004 and (b) 30th August 2011. There has been little change in the lower part of the cliff in the outcrops A, B and C of the sandstones and mudstones in the Pennington Point Member. In contrast, the collapse of Head Deposits and weathered mudstones in the upper part of the cliff adjacent to the coastal path (in 2008, 2009 and 2010), between there and the promontory D (in February 2009) and at promontory E have resulted in the local retreat of the cliff top by up to 2 m.

Most of the landslides in recent years have been relatively frequent (one or more per year) collapses in thick drift deposits in the highest part of the western end of the cliff close to the river and adjacent to the coastal footpath (Figure 8). These have been visible from the Esplanade and, as a consequence, have attracted much publicity.
