Local coastal defences:

varying degrees of success!

The area under consideration – Weymouth Bay from Greenhill to Redcliff Point.

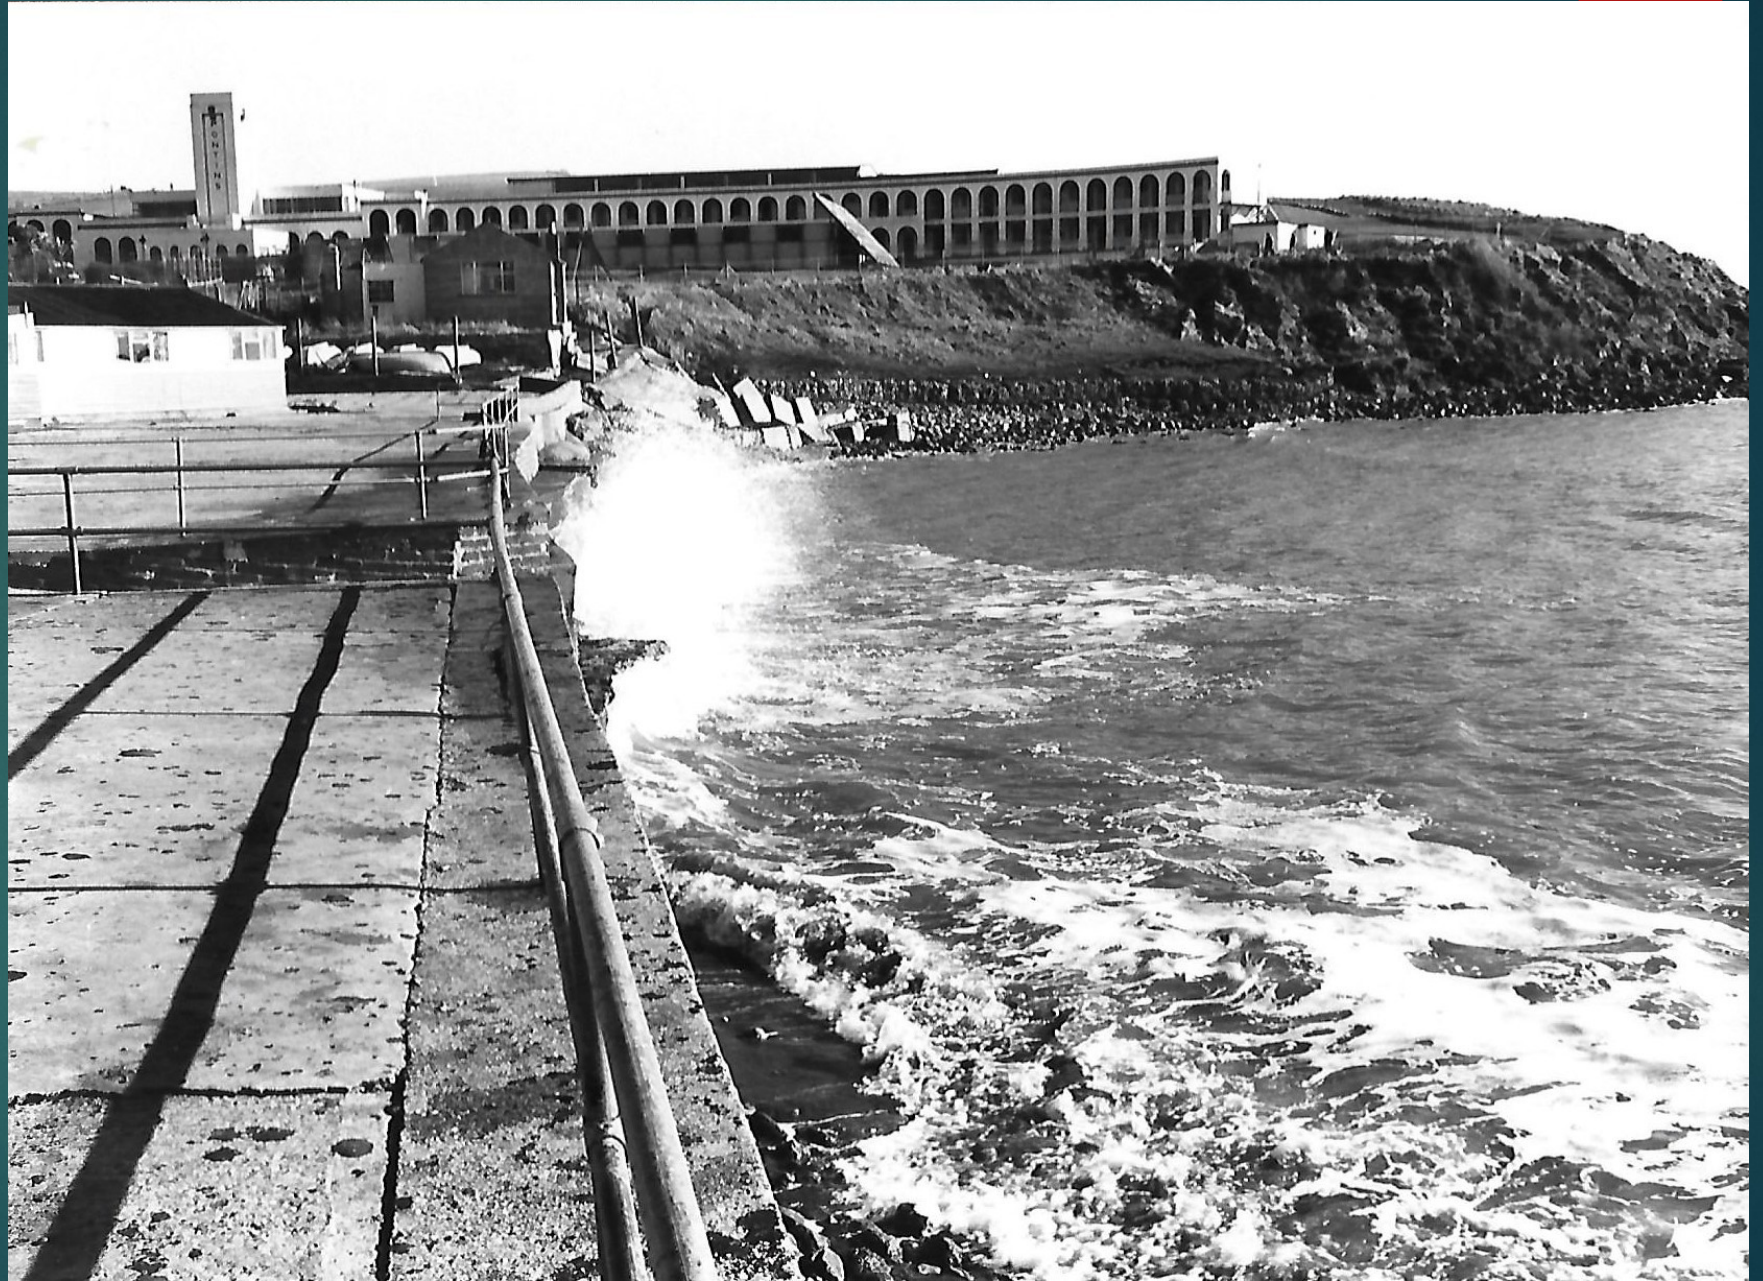
View of Bowleaze
Cove, autumn 1978
with gabions at back
of beach and hard
engineering.

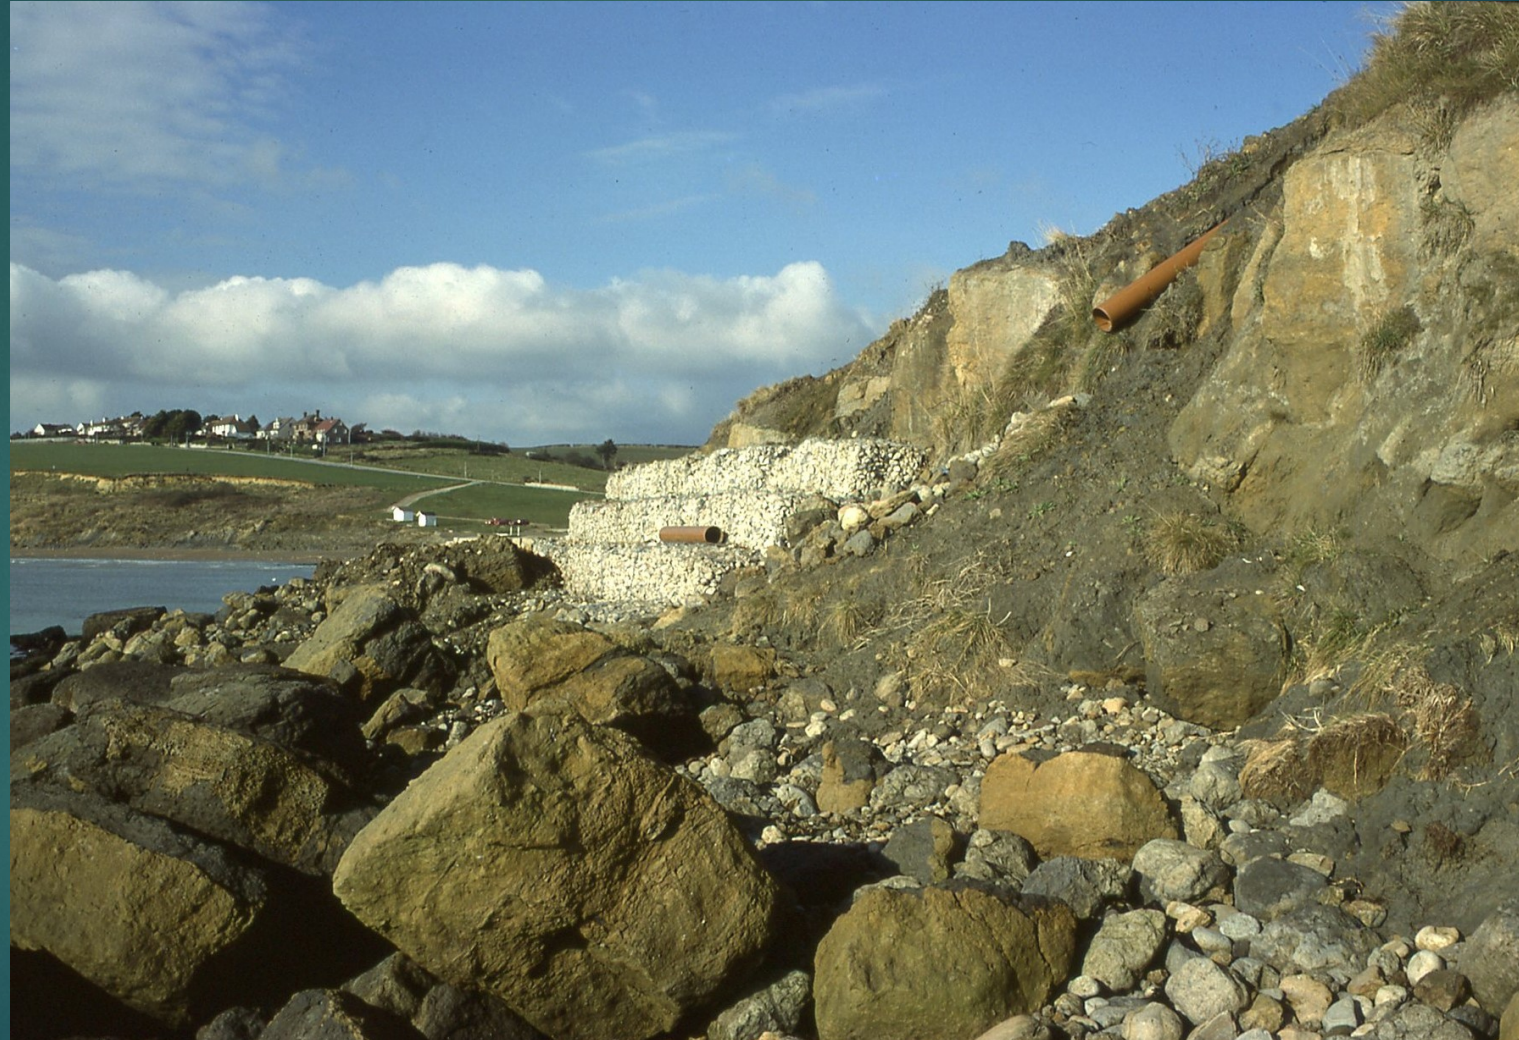
Protection for
Riviera Hotel,
gabions,
drainage and
slope grading
November
1980.
Cost £60,000.

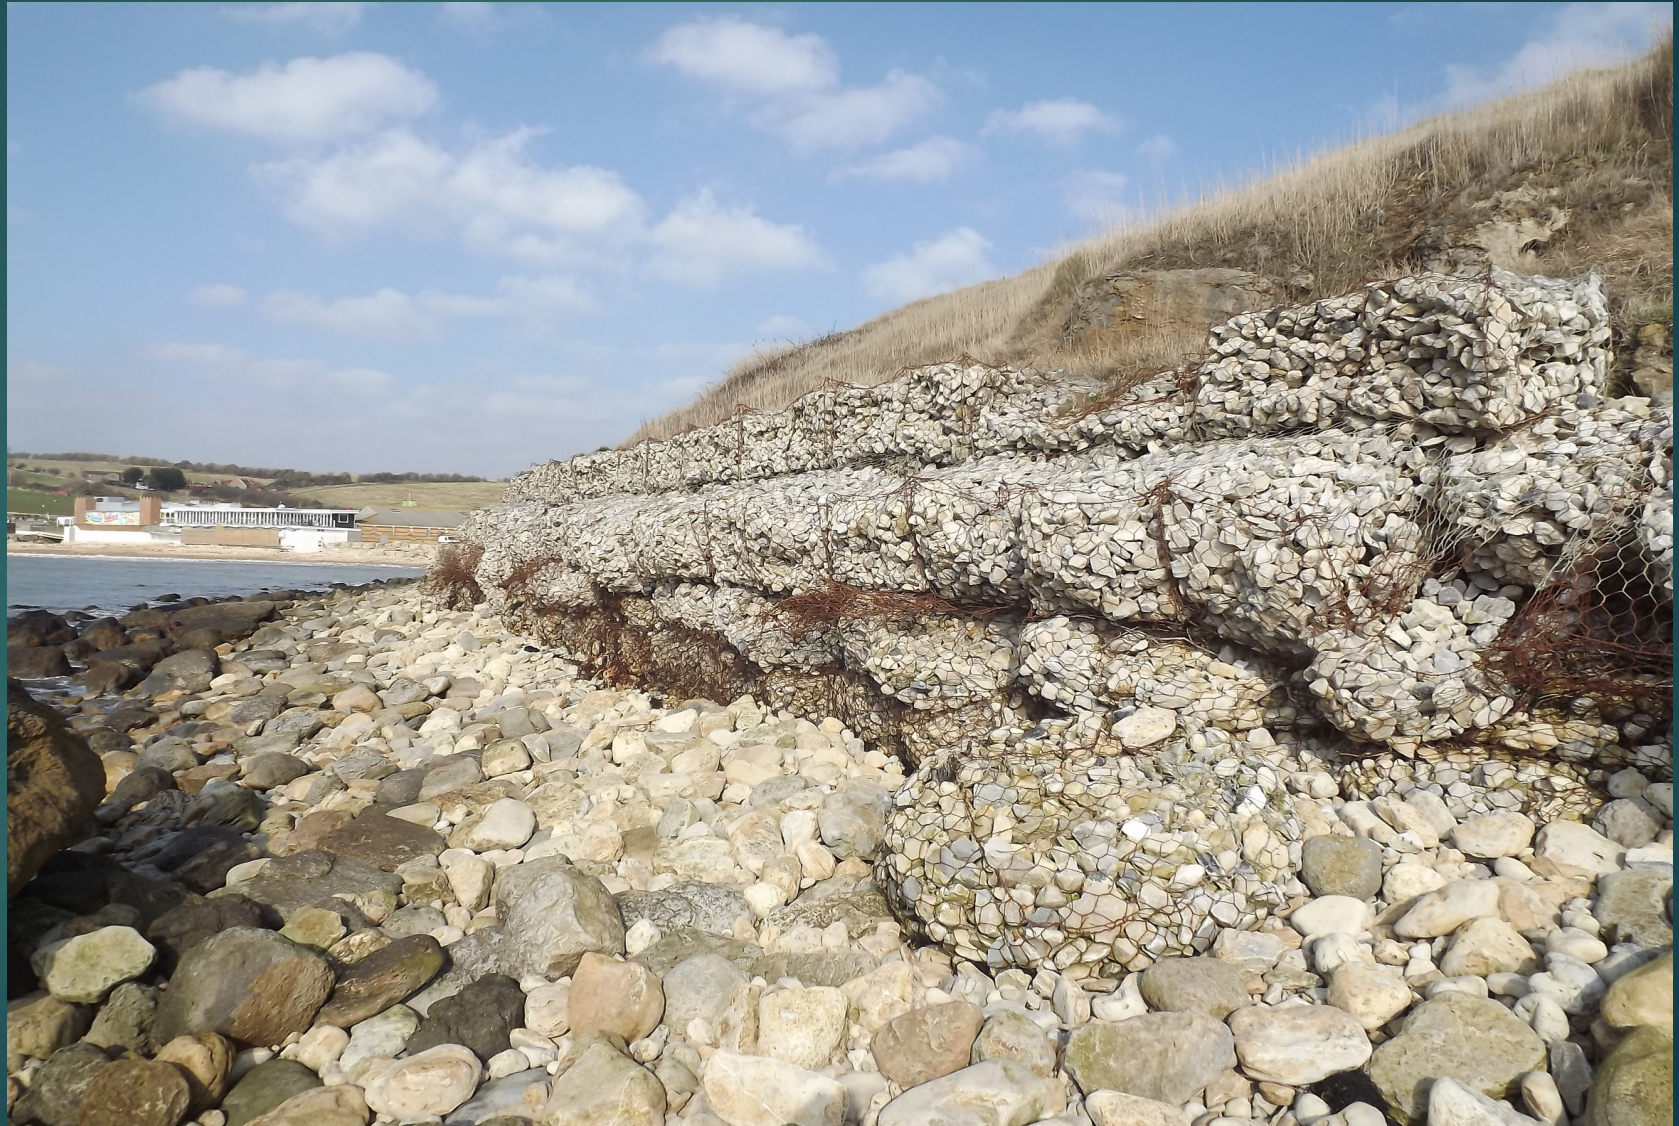
.....and
February 2018.
So nearly 40
years on, a
success if not
very attractive!

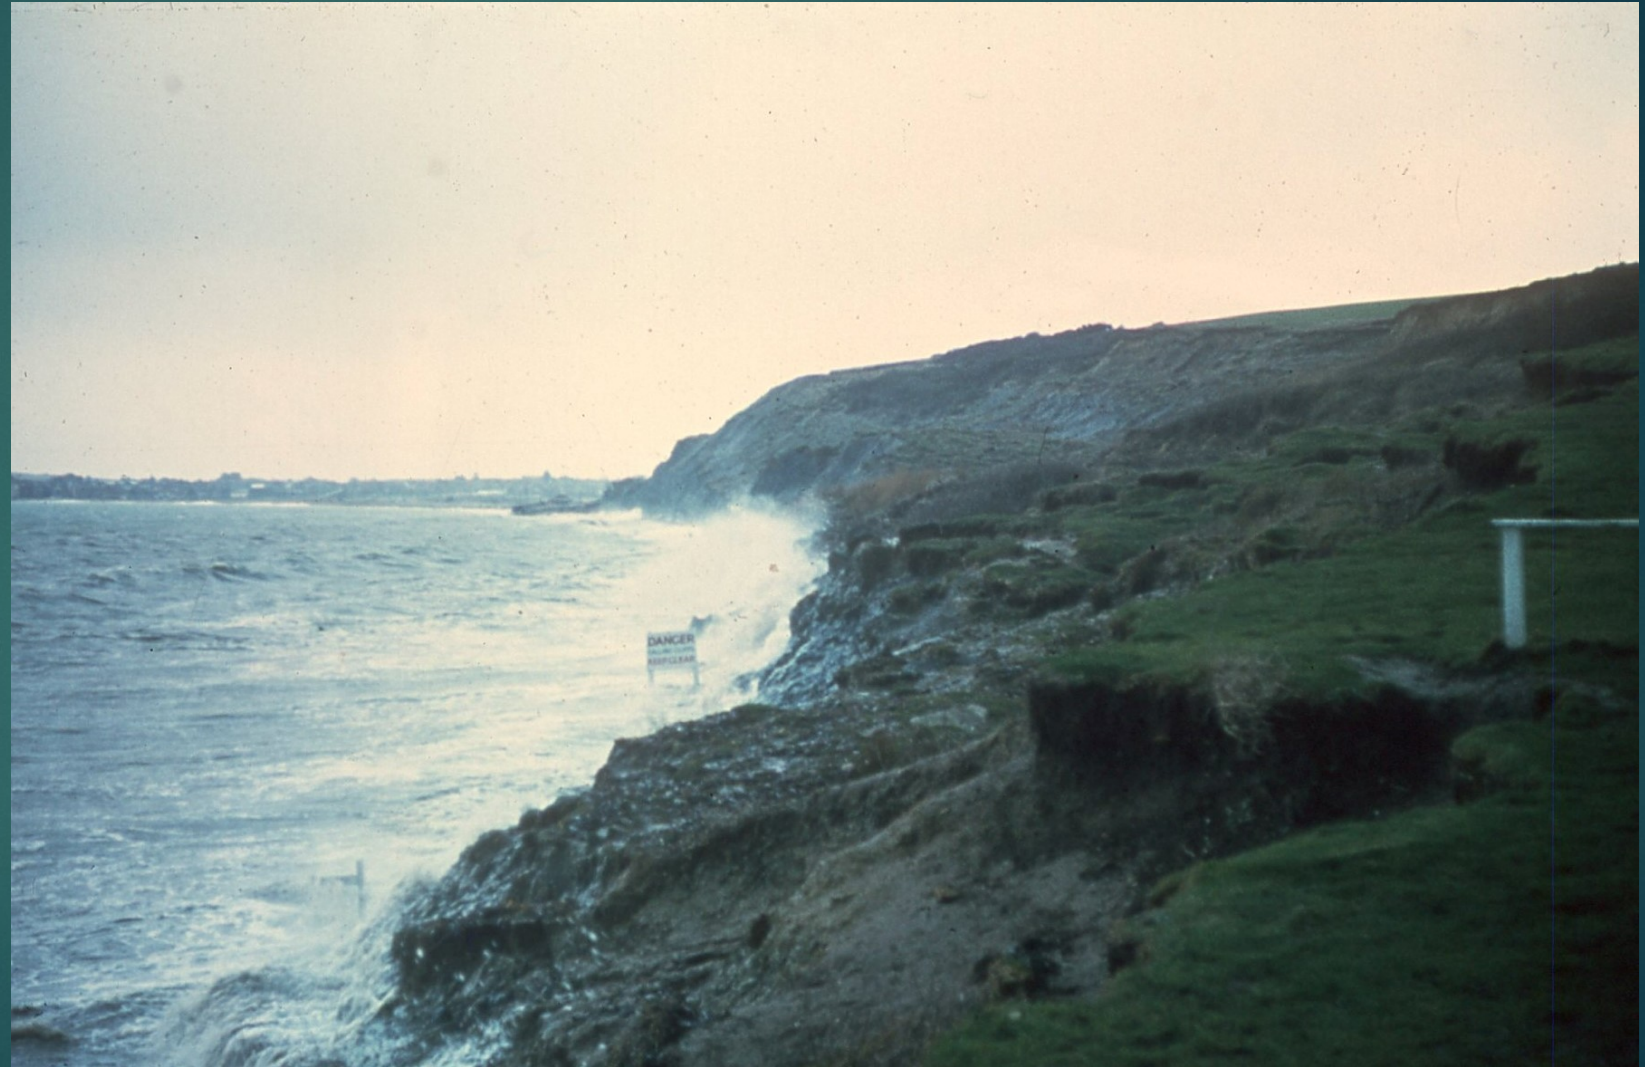
High tide and
stormy
conditions
1970s? Serious
marine erosion
of the Oxford
Clay.

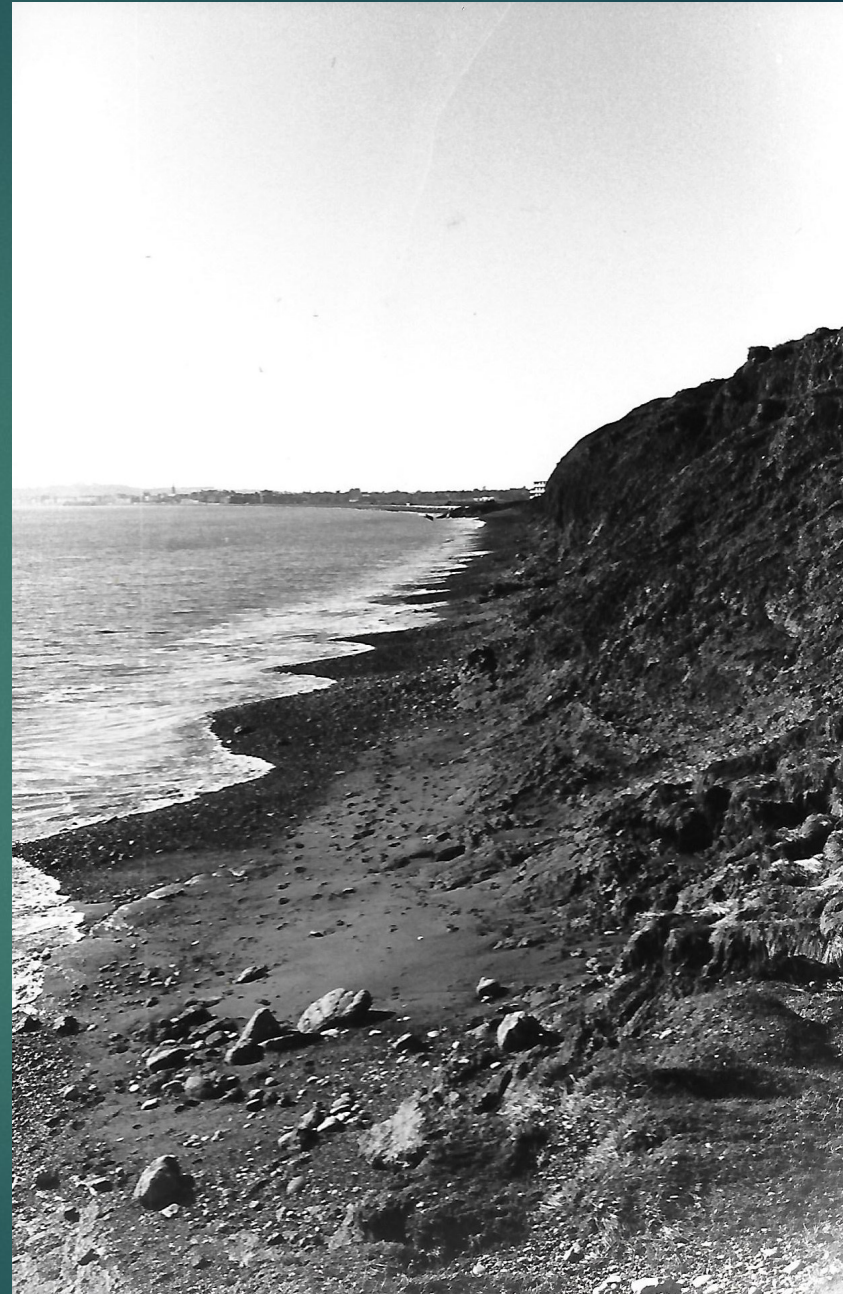
More peaceful
conditions 1978 and
early 1980s, steep
slope of the clay cliff
means it was unstable.

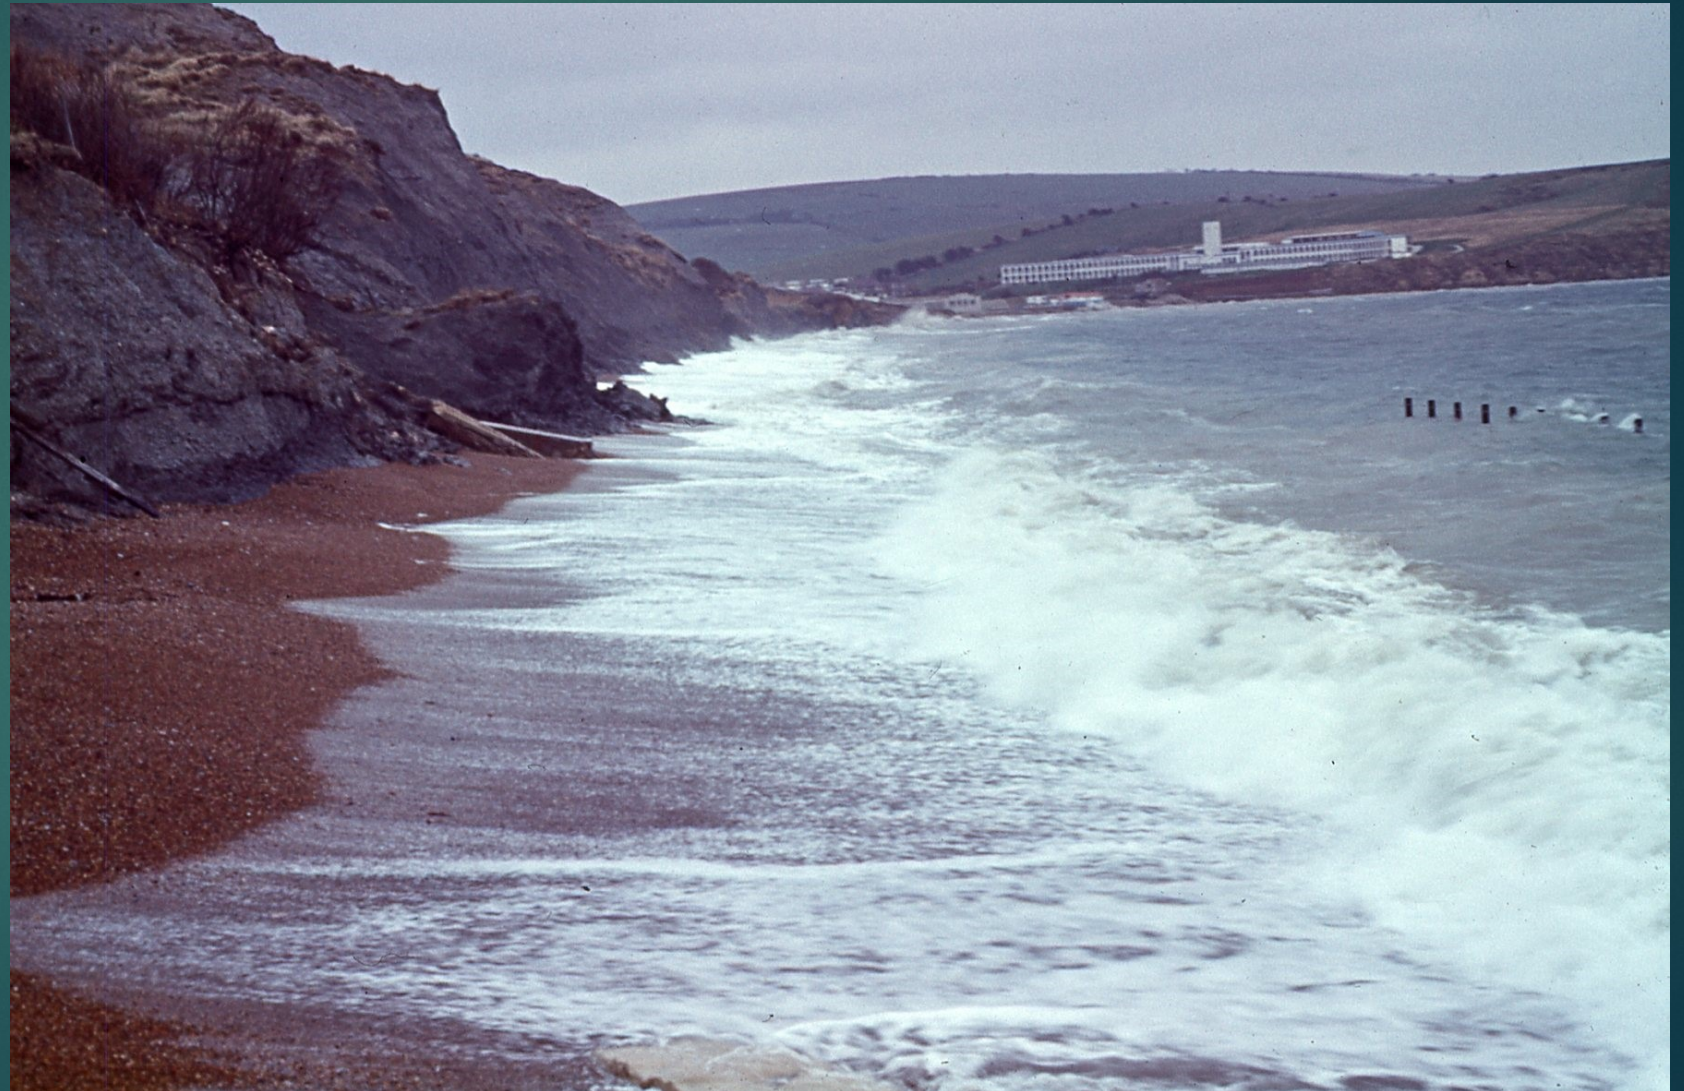
Another view
looking from
Overcombe Corner,
1970s. Evidence of
old coastal
defences
offshore.....

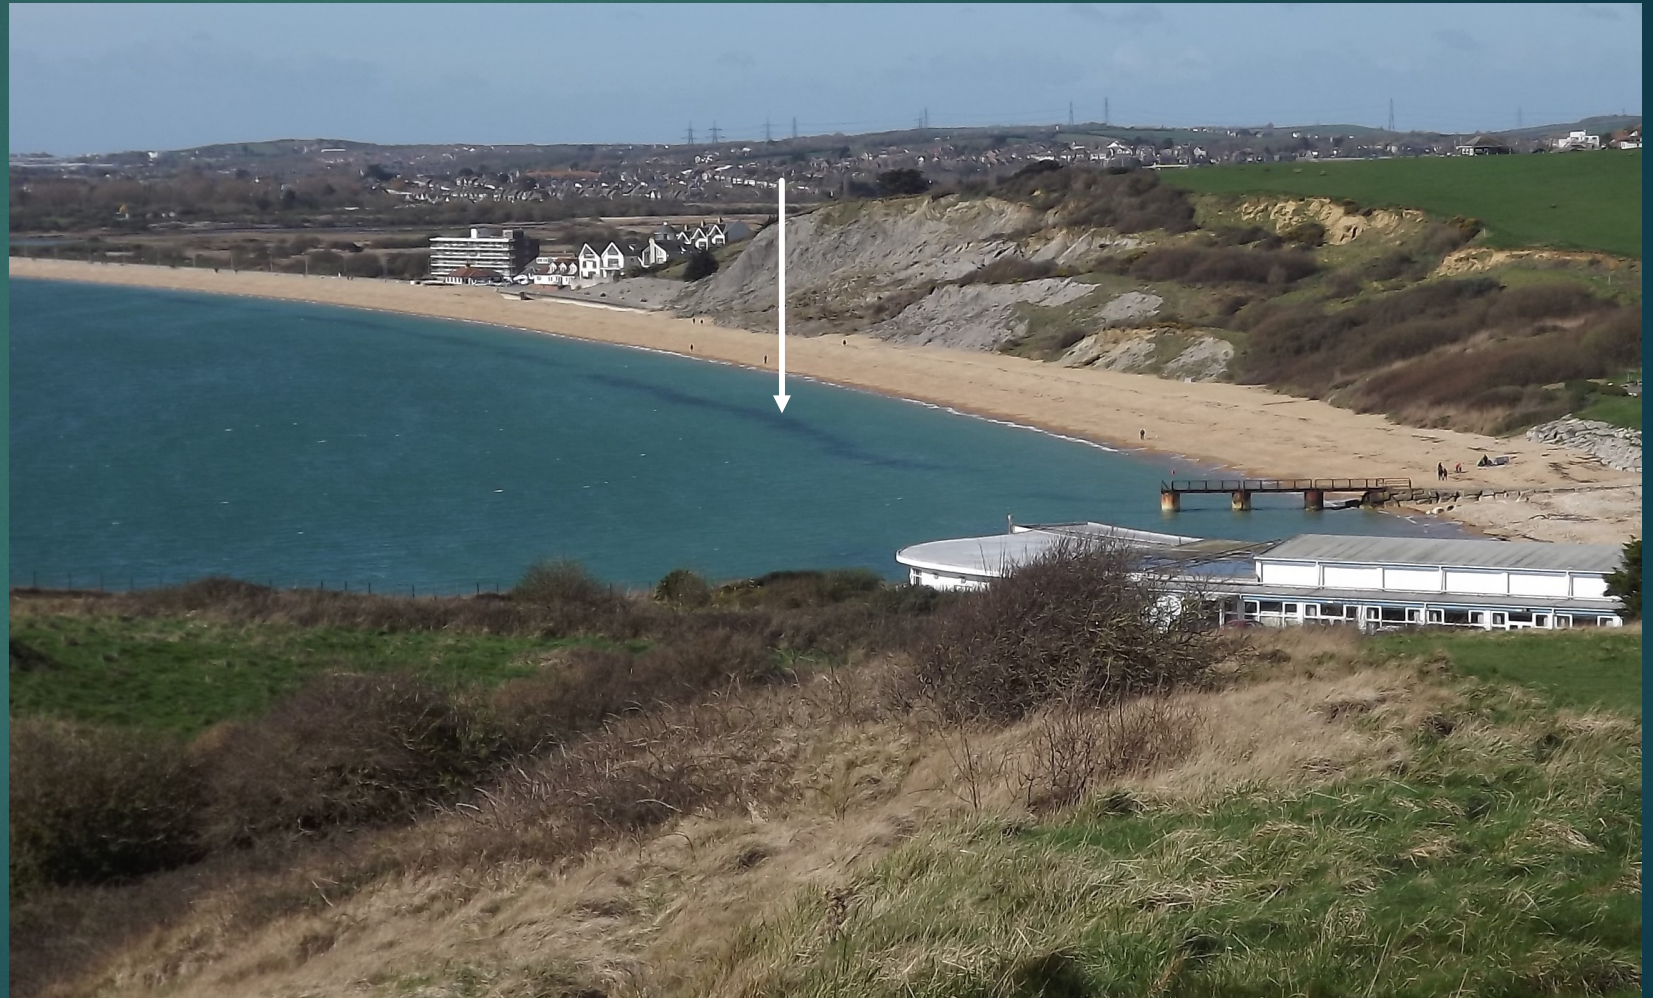
...and even older,
off shore evidence
of rock armour
from late
Victorian
attempts to limit
erosion.

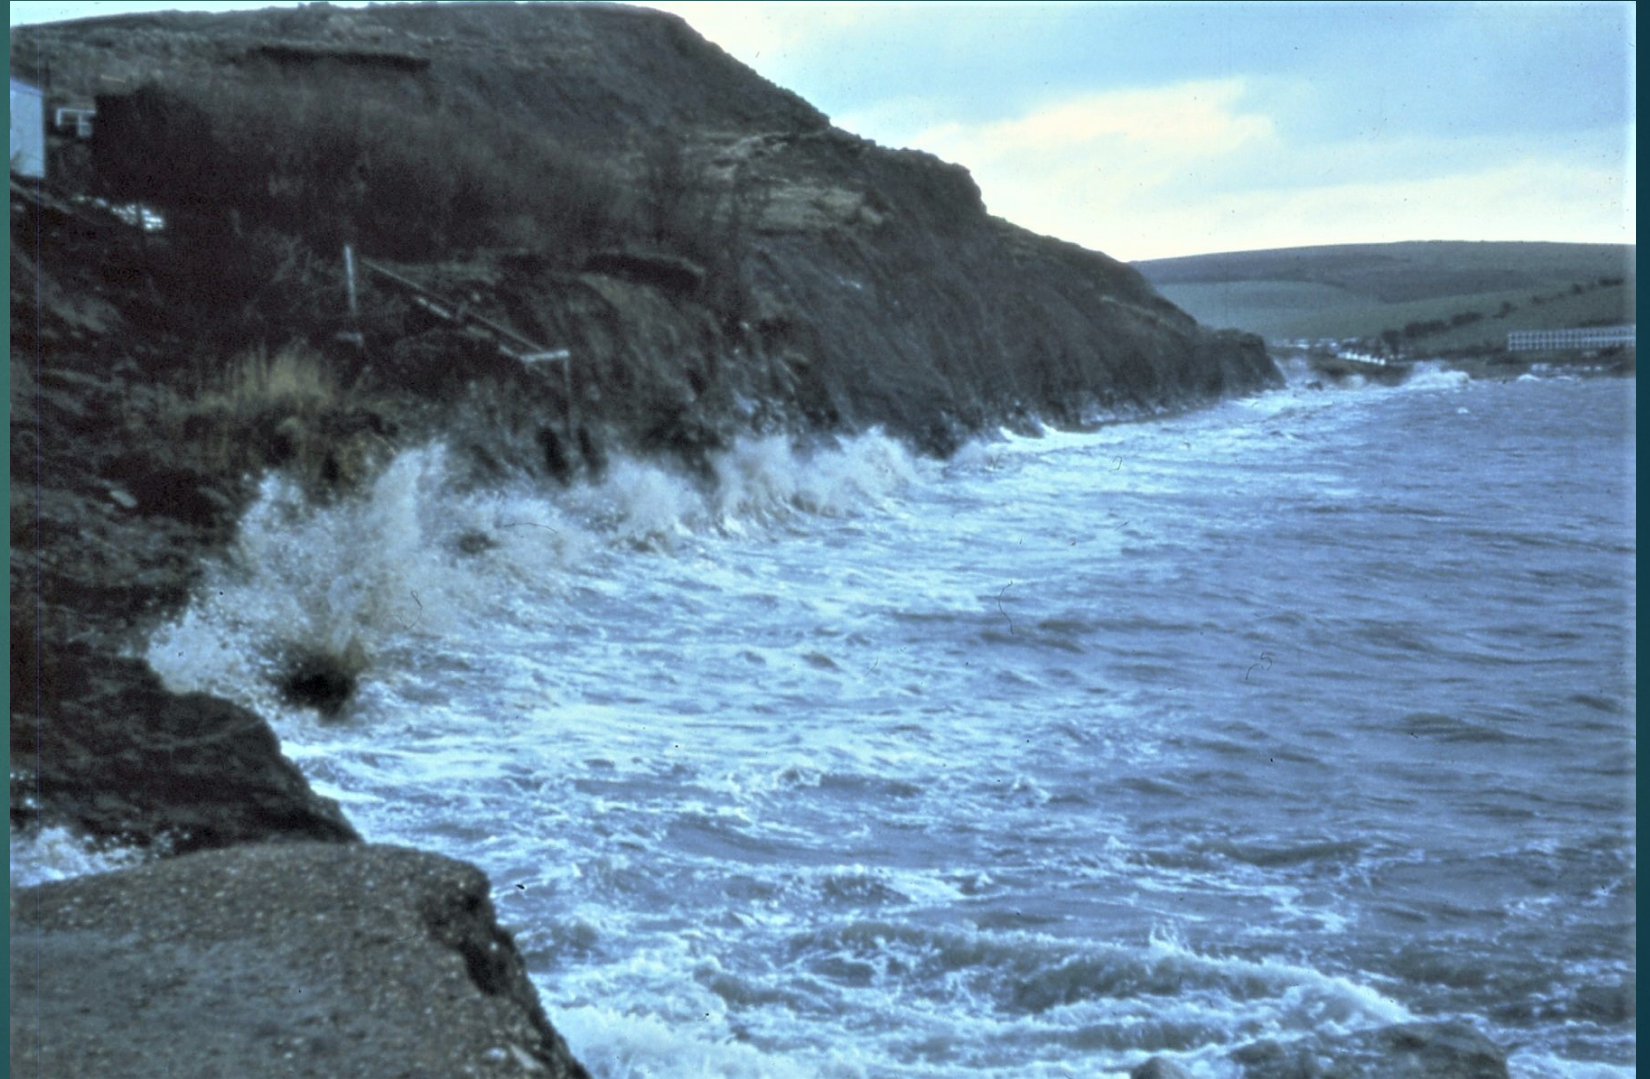
High tide at Overcombe
resulting in further
erosion particularly of
the Oxford Clay.

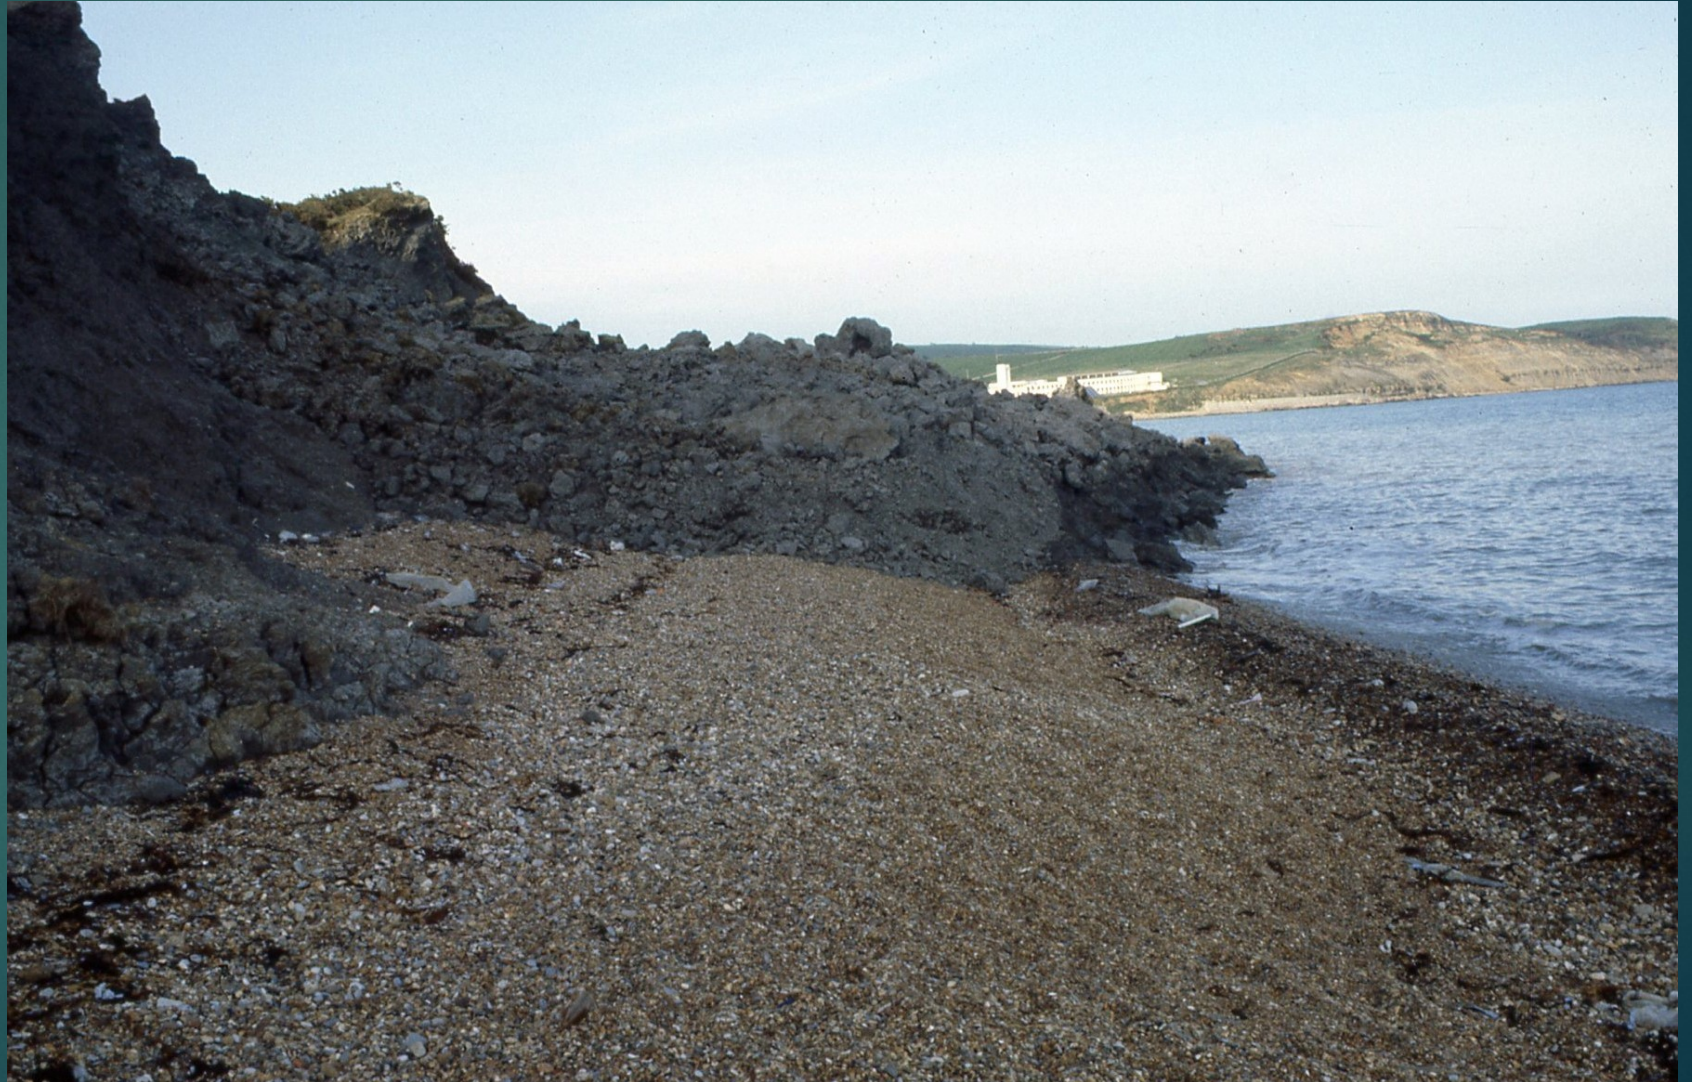
Oxford Clay
slumping across the
beach, 1980s
picture.

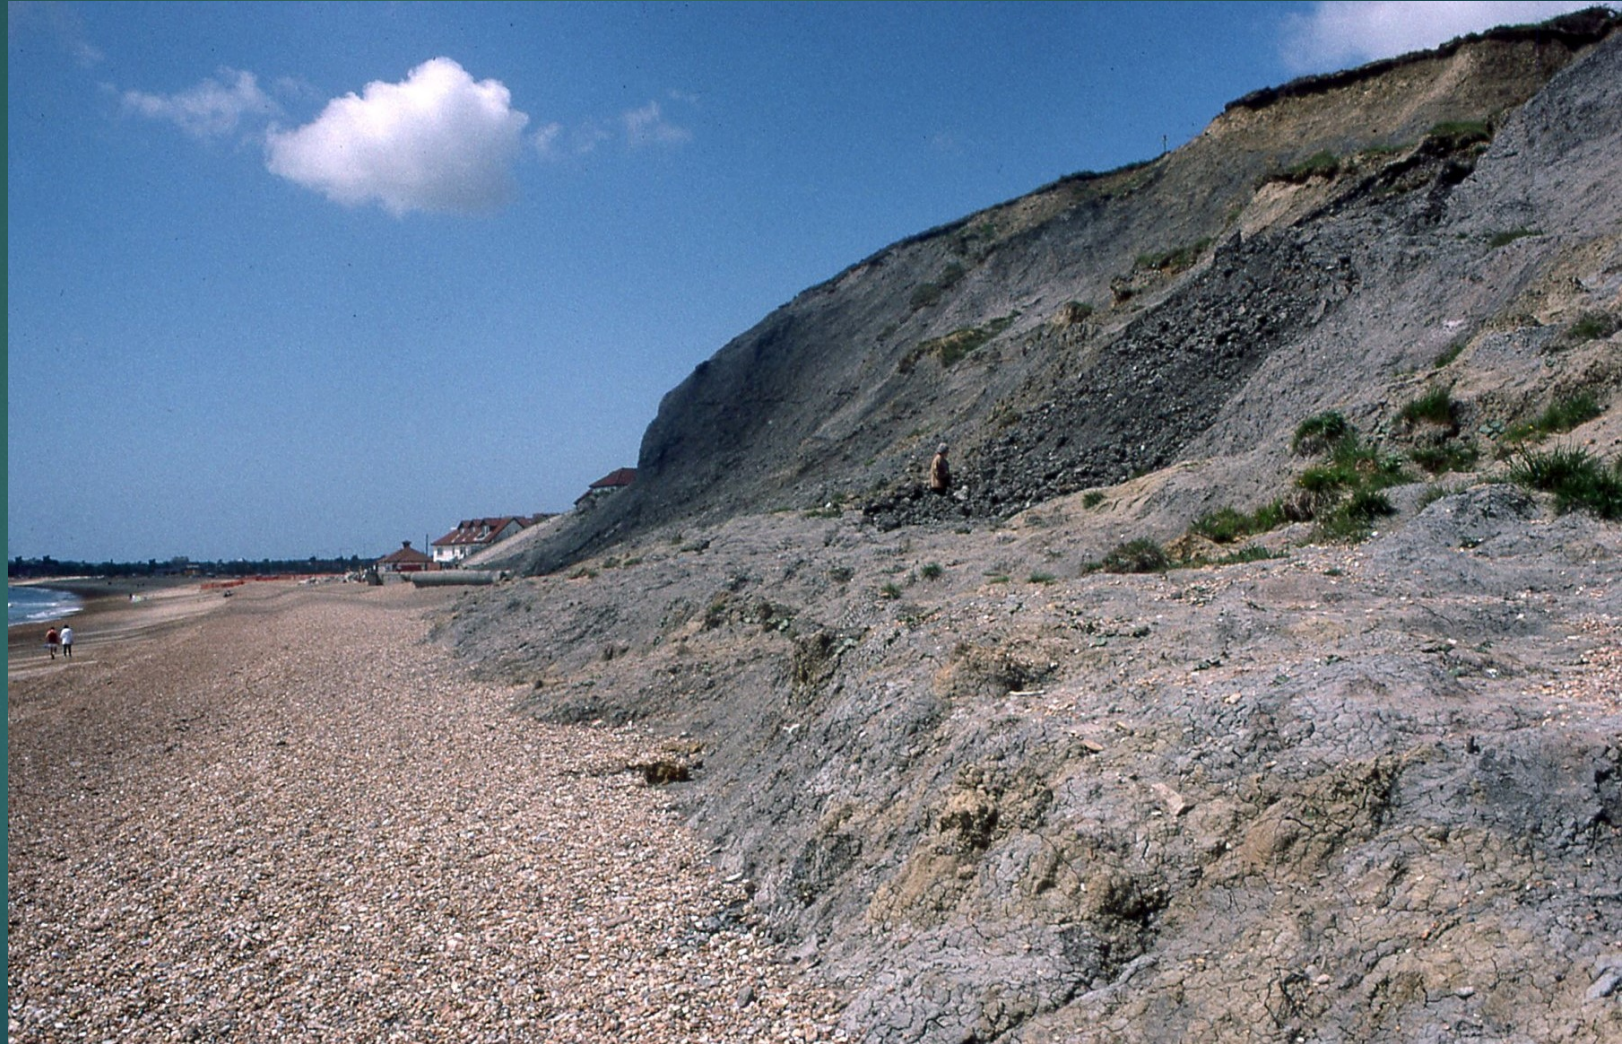
View taken
24.7.1996
following
Preston Beach
Road Scheme
beach
replenishment.
Furzy Cliff now
protected from
marine erosion
except in
extreme
circumstances.

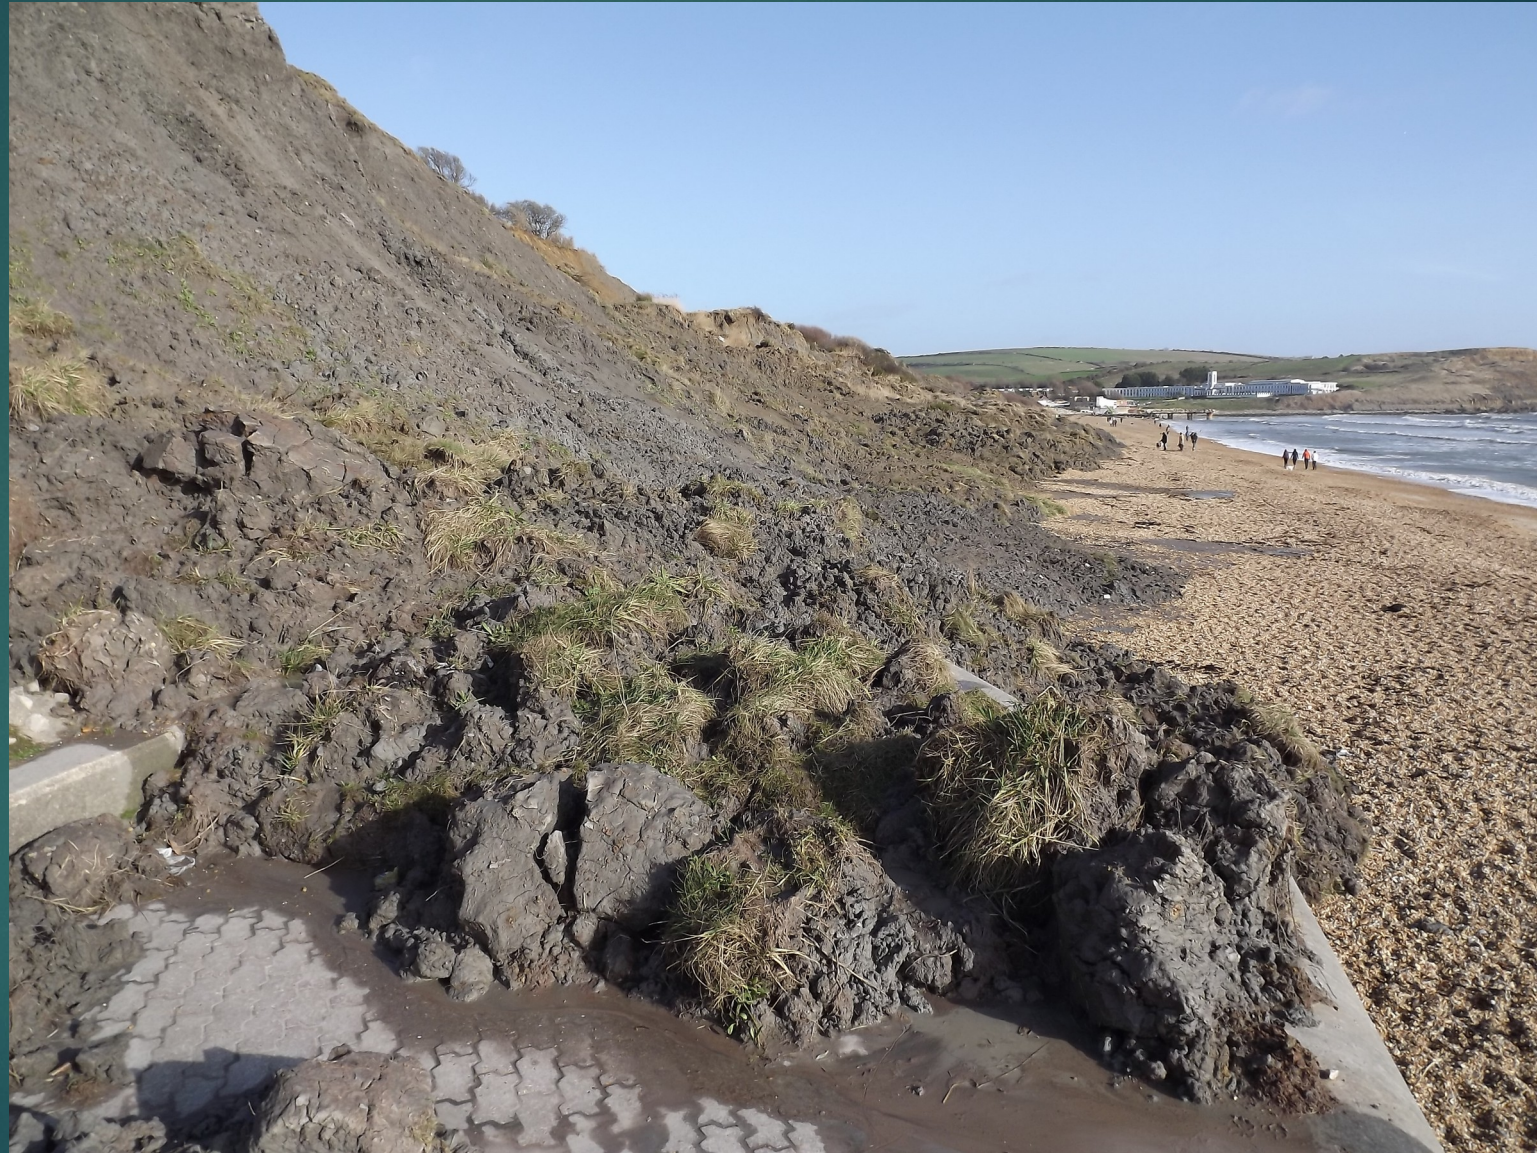
View 27.1.2013,
slumping still
occurs after wet
weather but it is
not as severe as
it was.

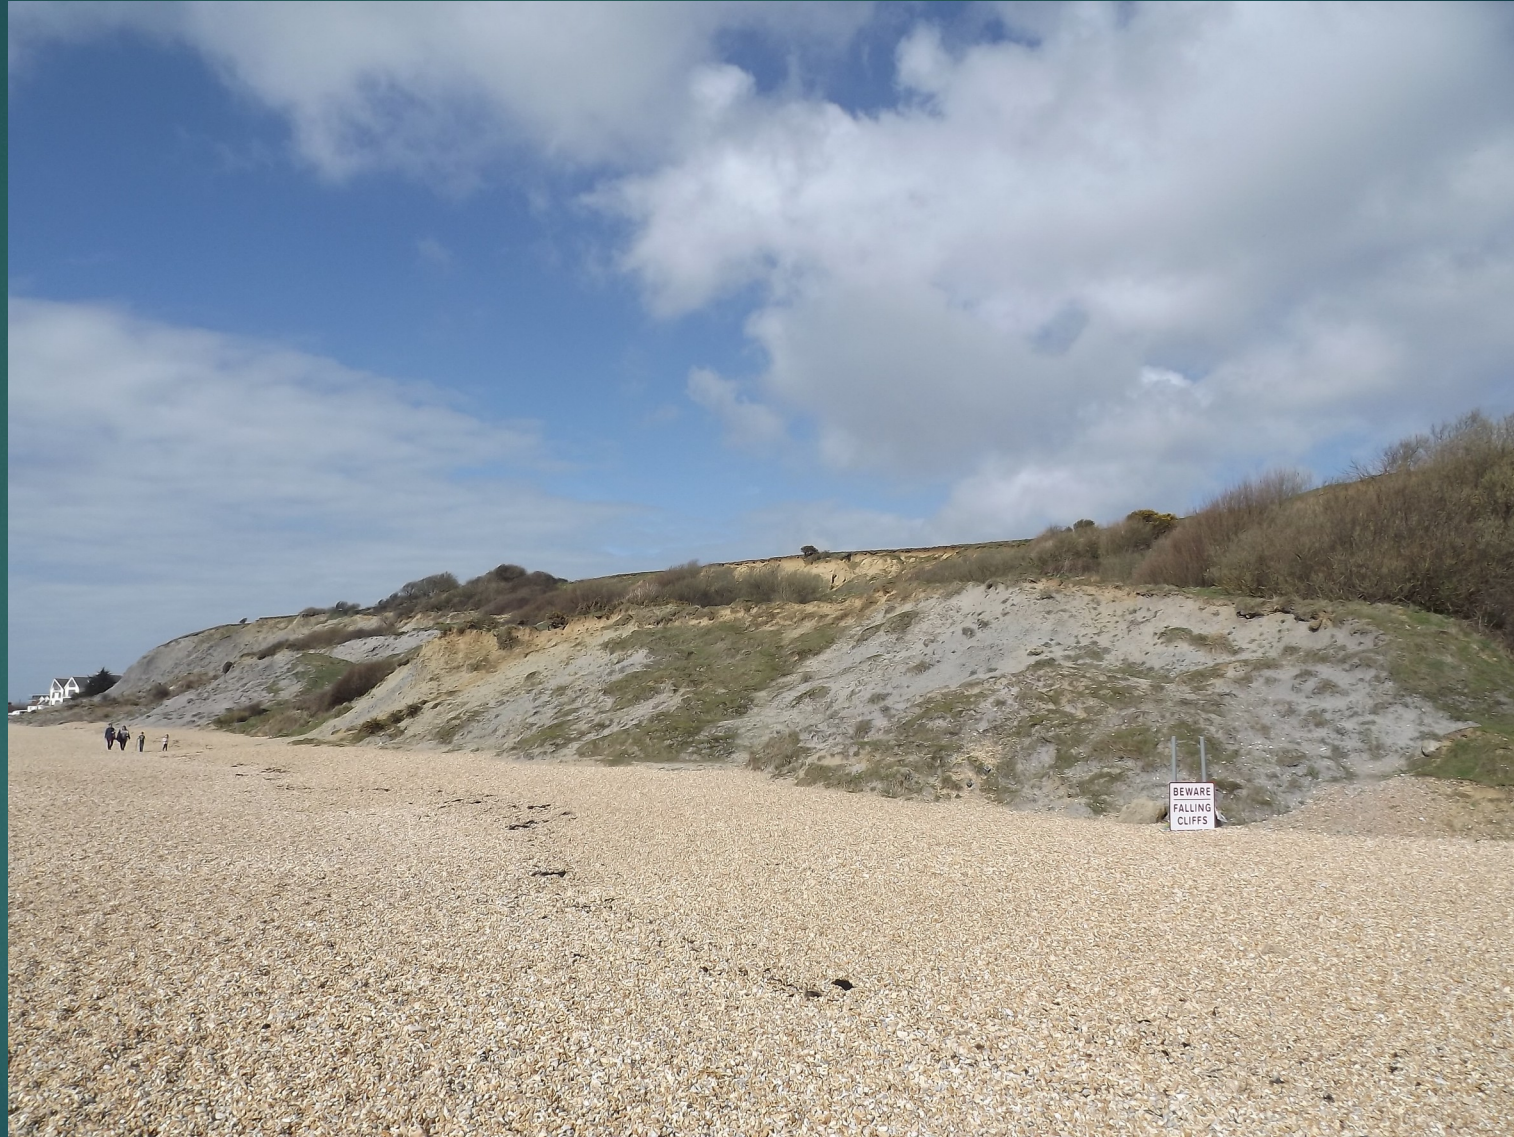
All change,
situation
8.4.2016. Beach
replenishment at
Preston Beach
Road has now
provided
protection for the
cliff so marine
erosion is unlikely
and subaerial
slumping has
created a more
stable slope

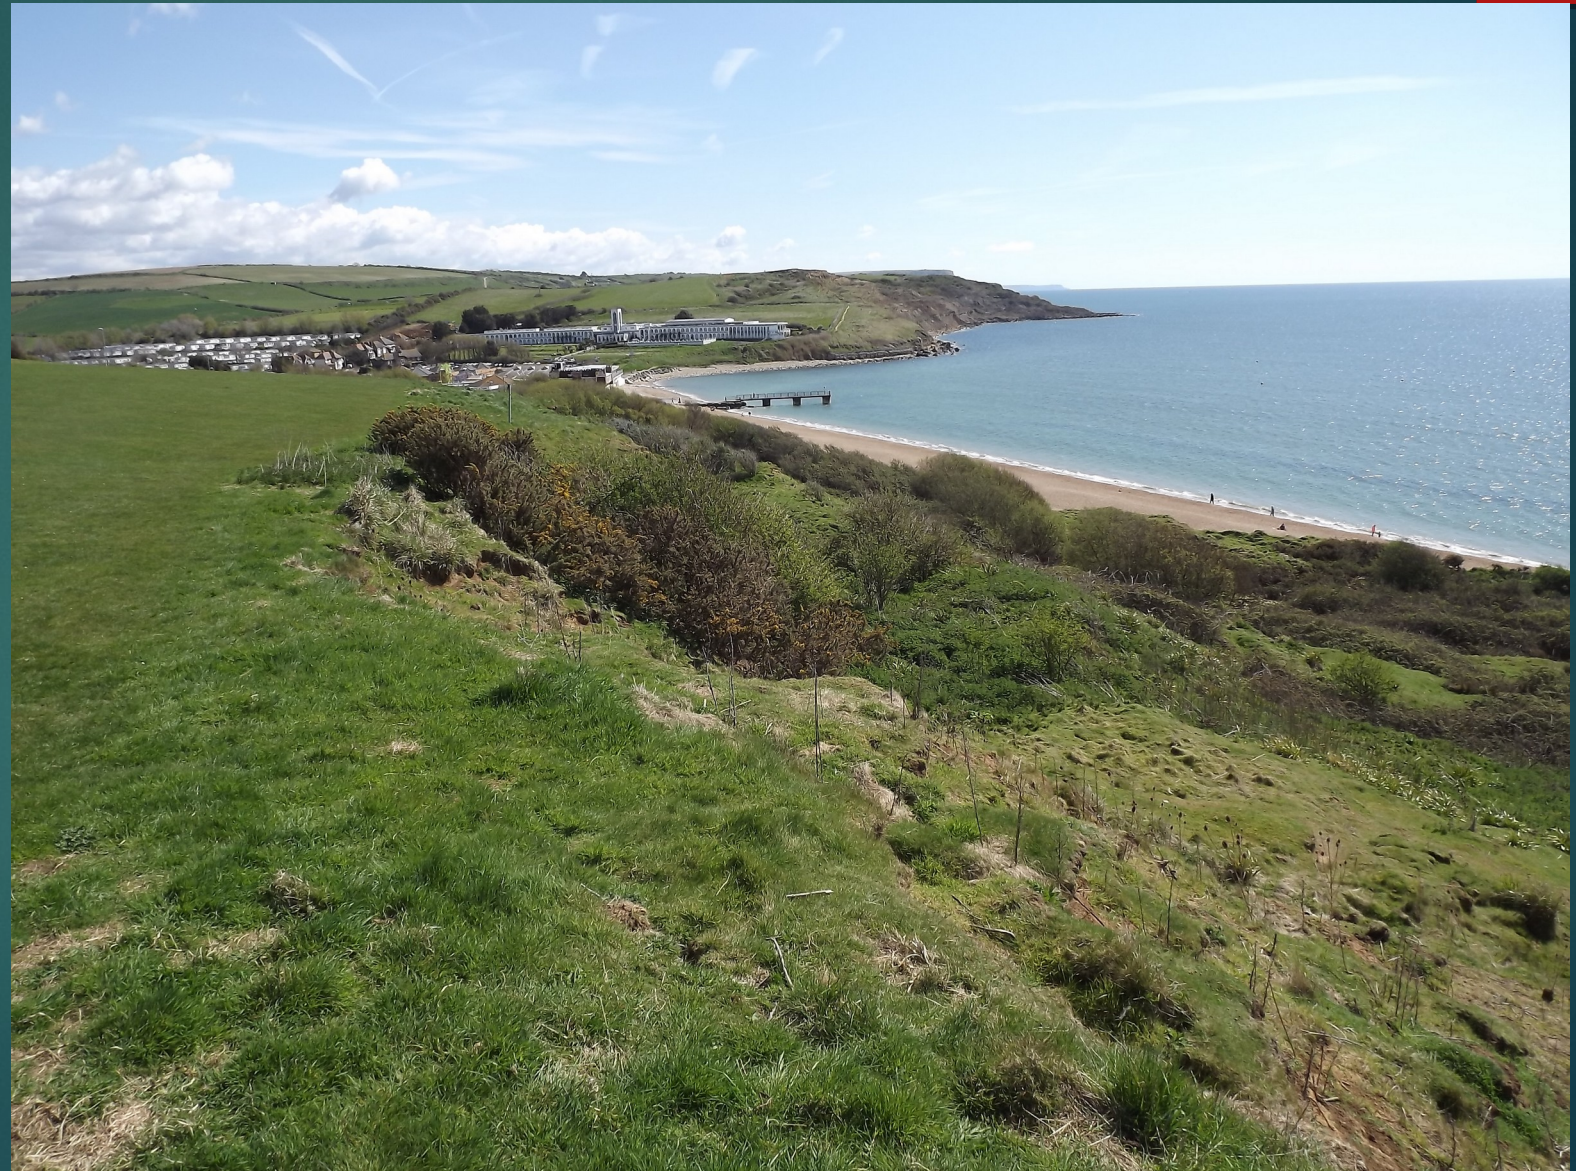
Eastern end of Furzy
Cliff April 2016, clear
evidence of greater
stability with well
established
vegetation.
