Local coastal defences:

varying degrees of success!

The area under consideration – Weymouth Bay from Greenhill to Redcliff Point.

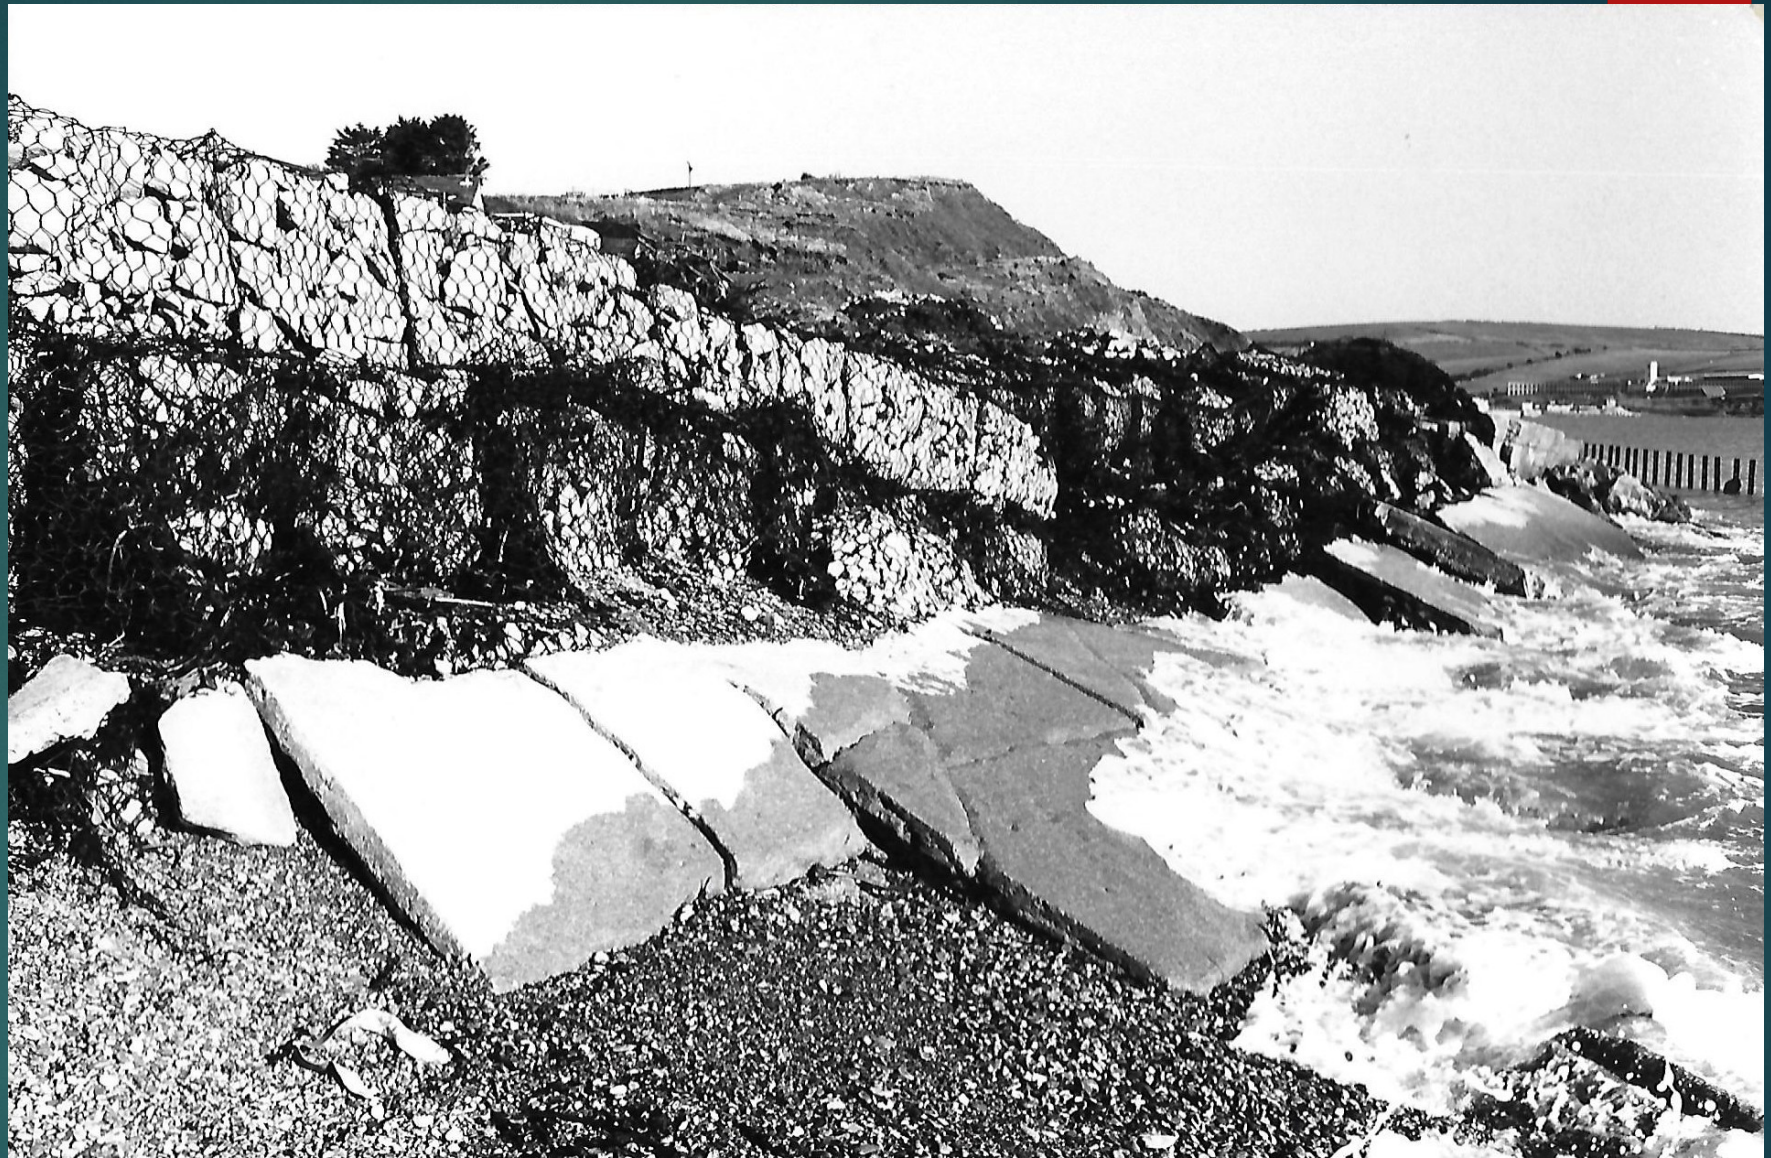
Closer view of
the defences,
date of
construction
unknown.

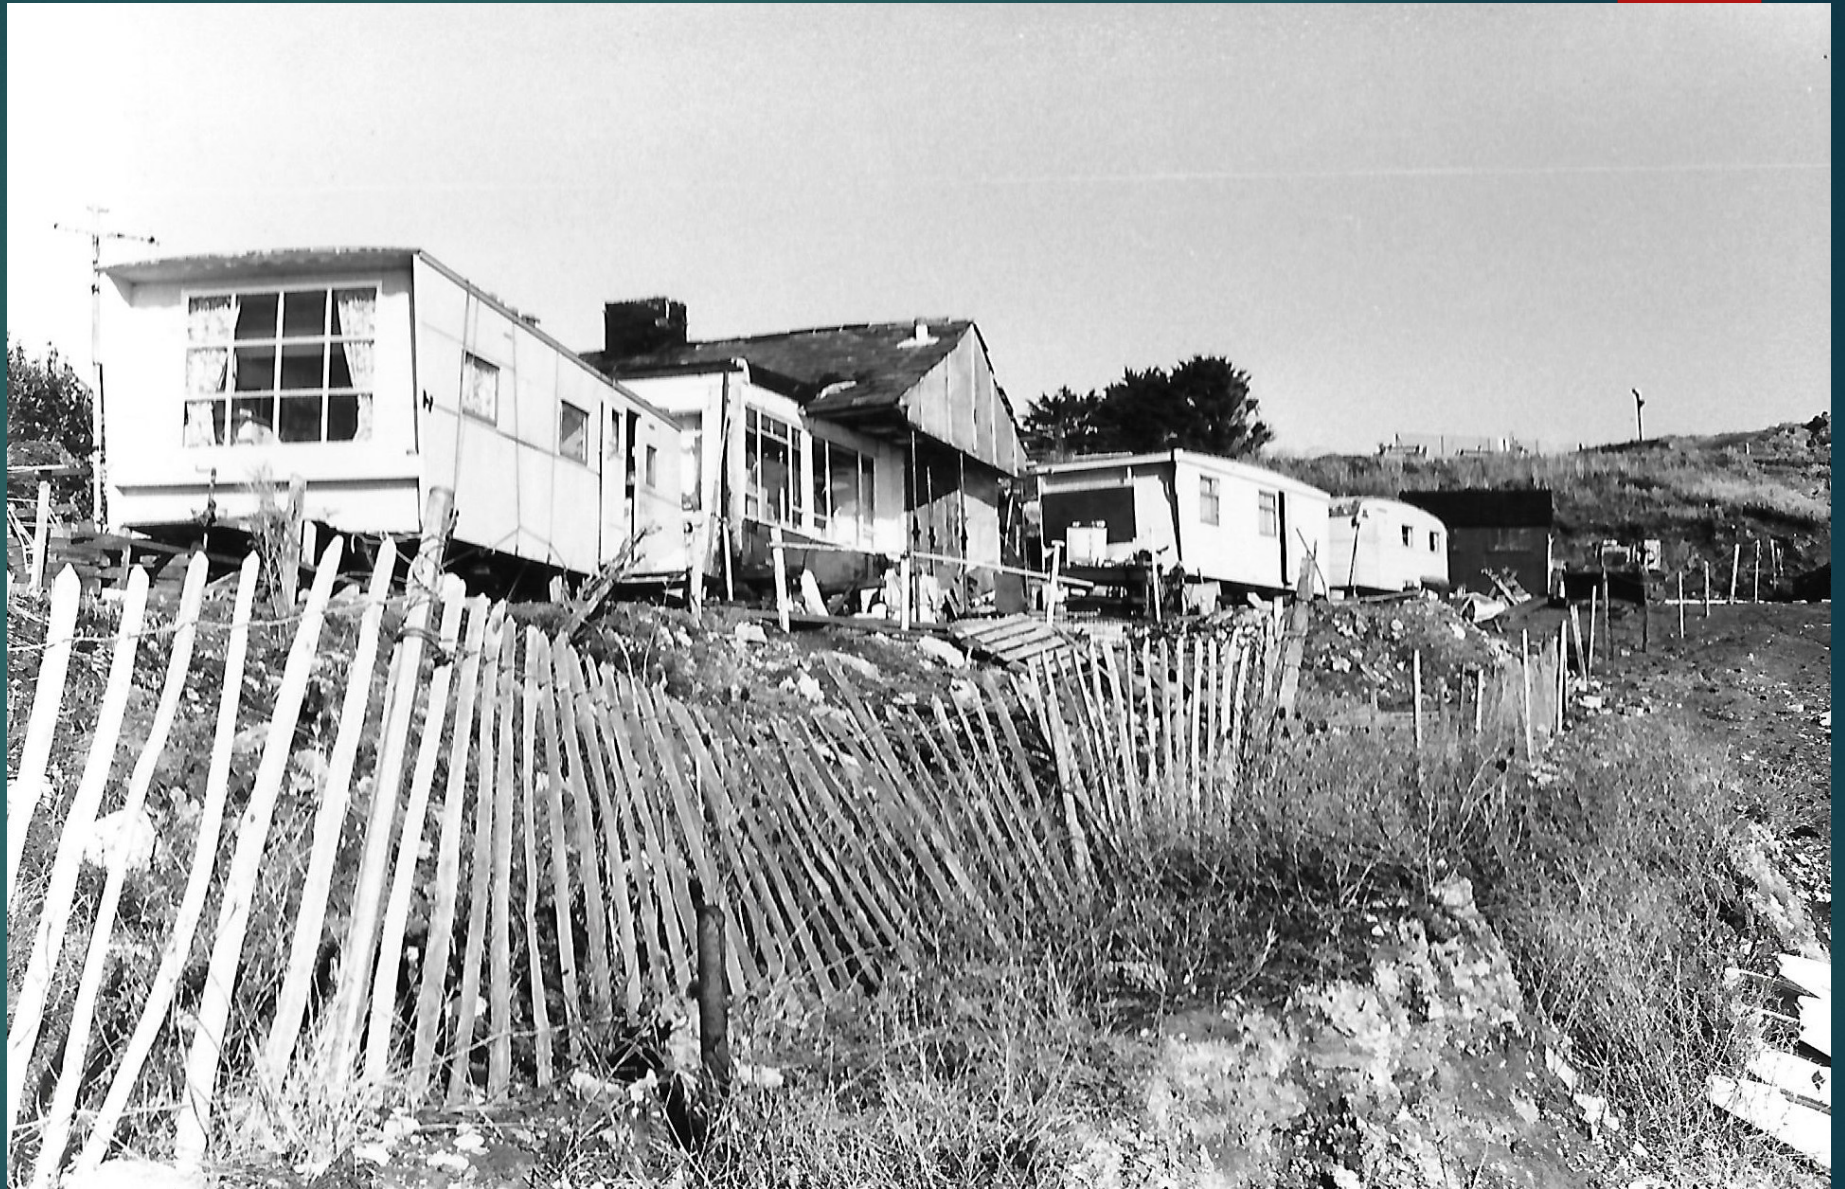
Damaged
coastguard
cottages 1978

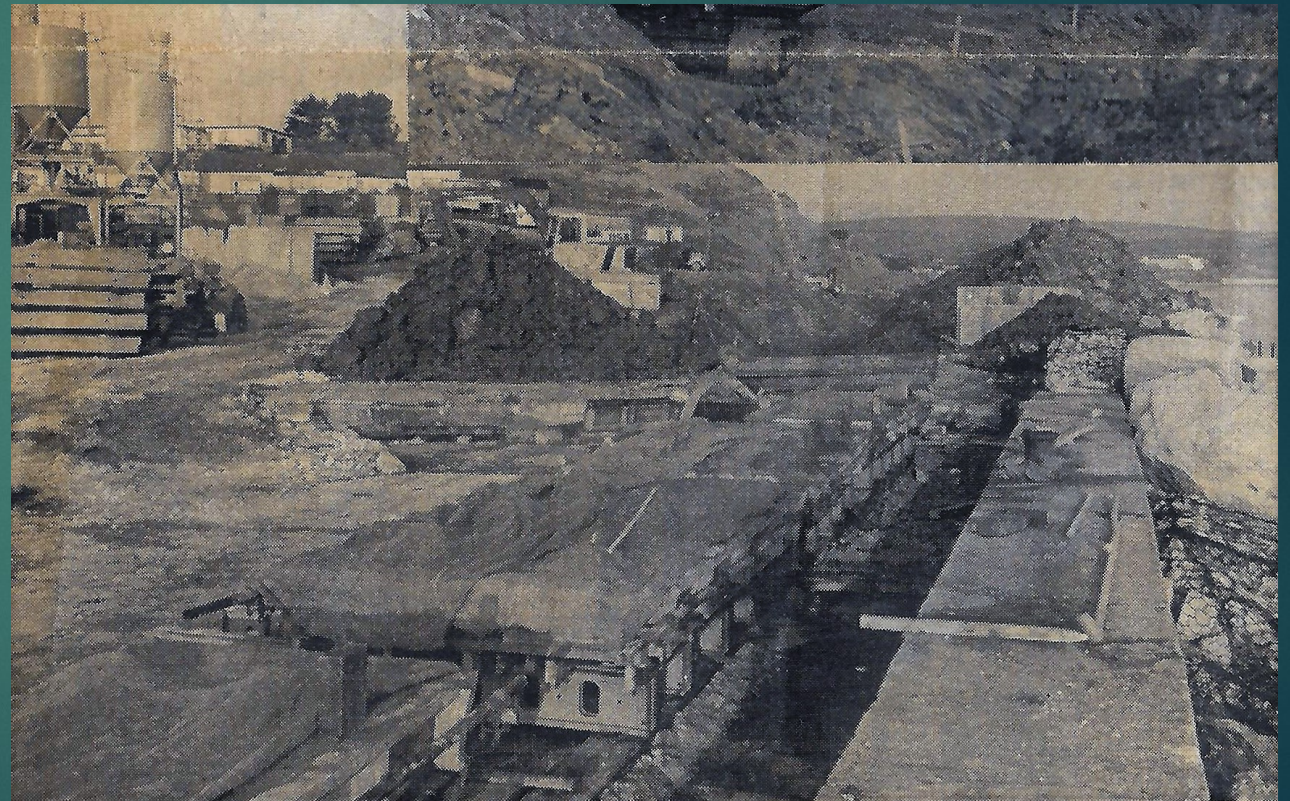
Coastal protection work
November 1983.

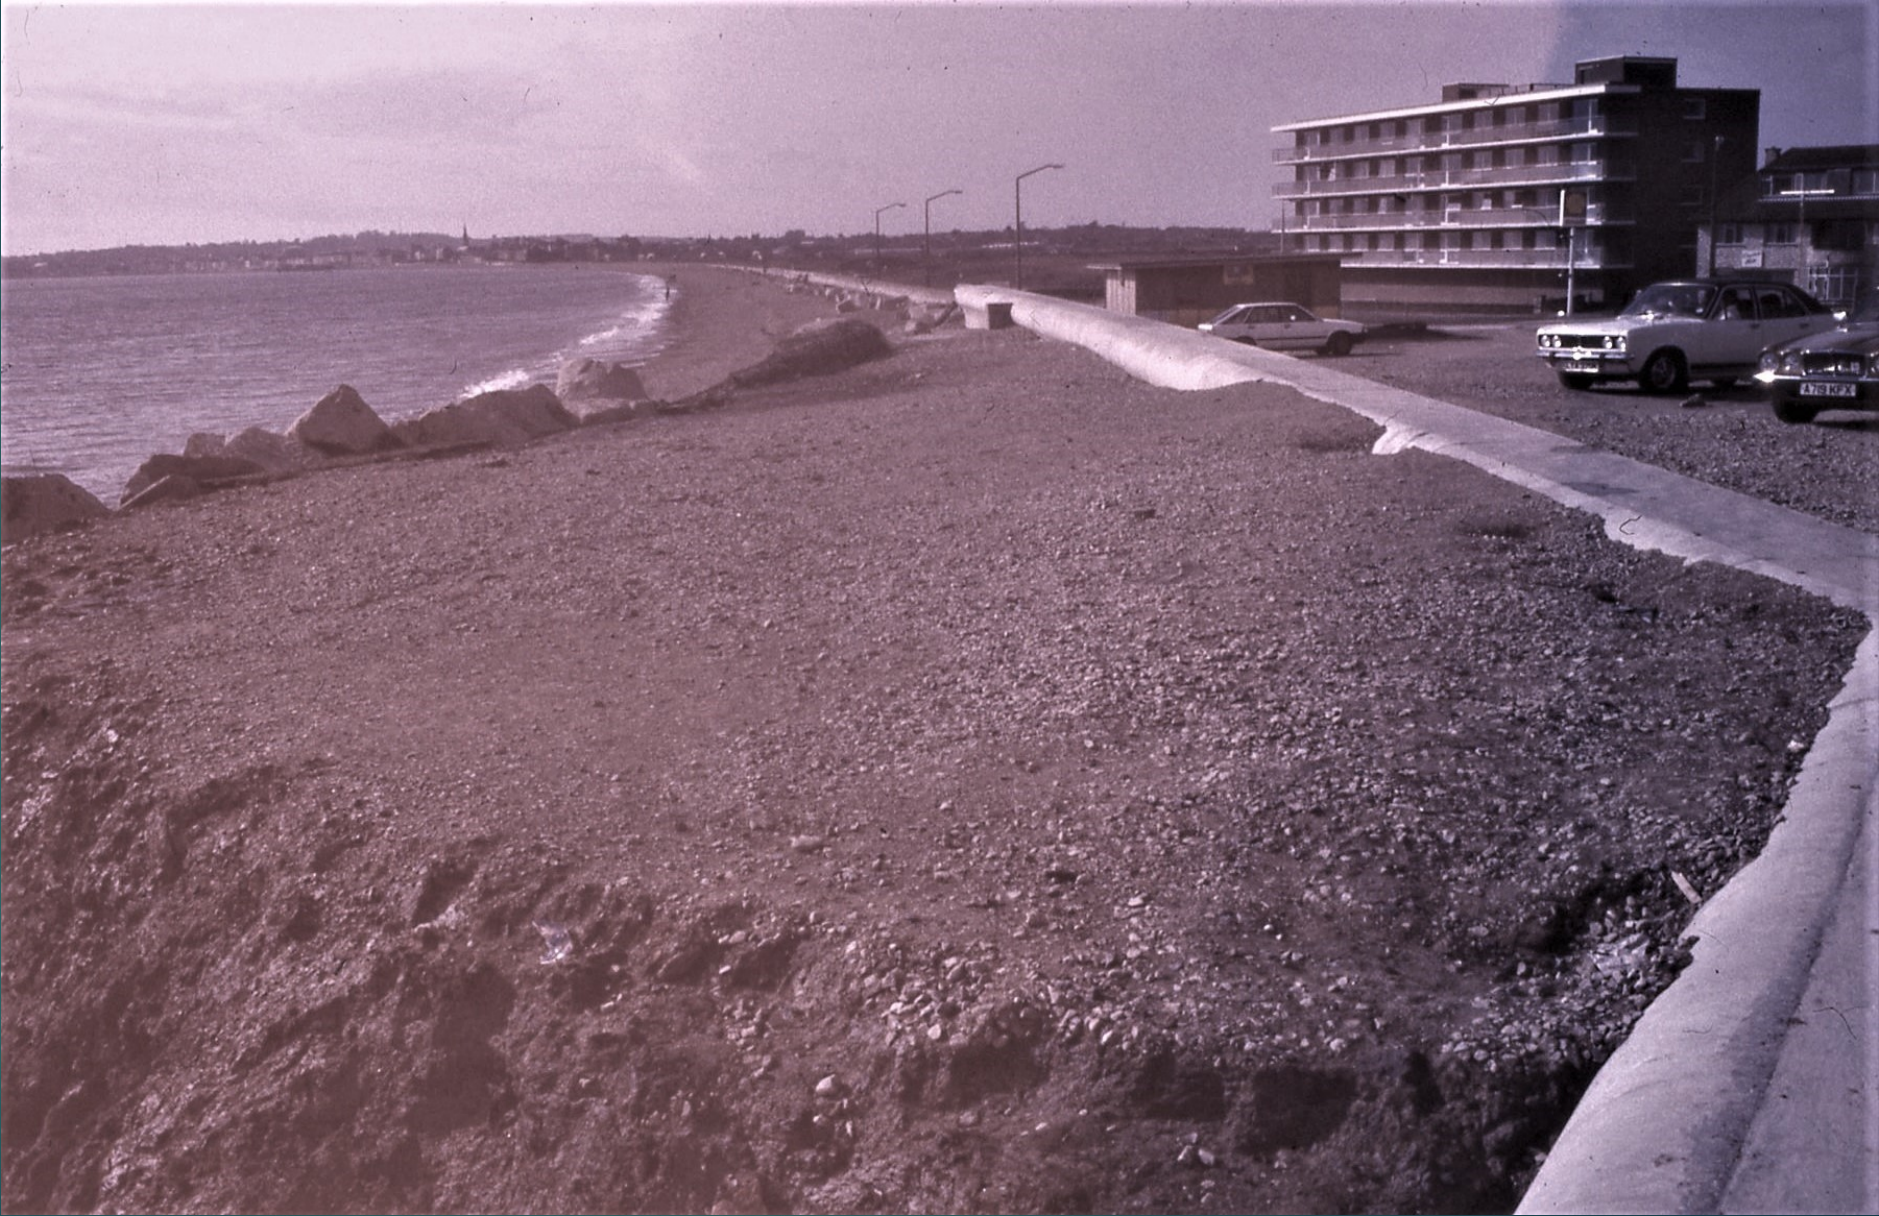
Picture taken in
March 1985 just
after protection
was finished.

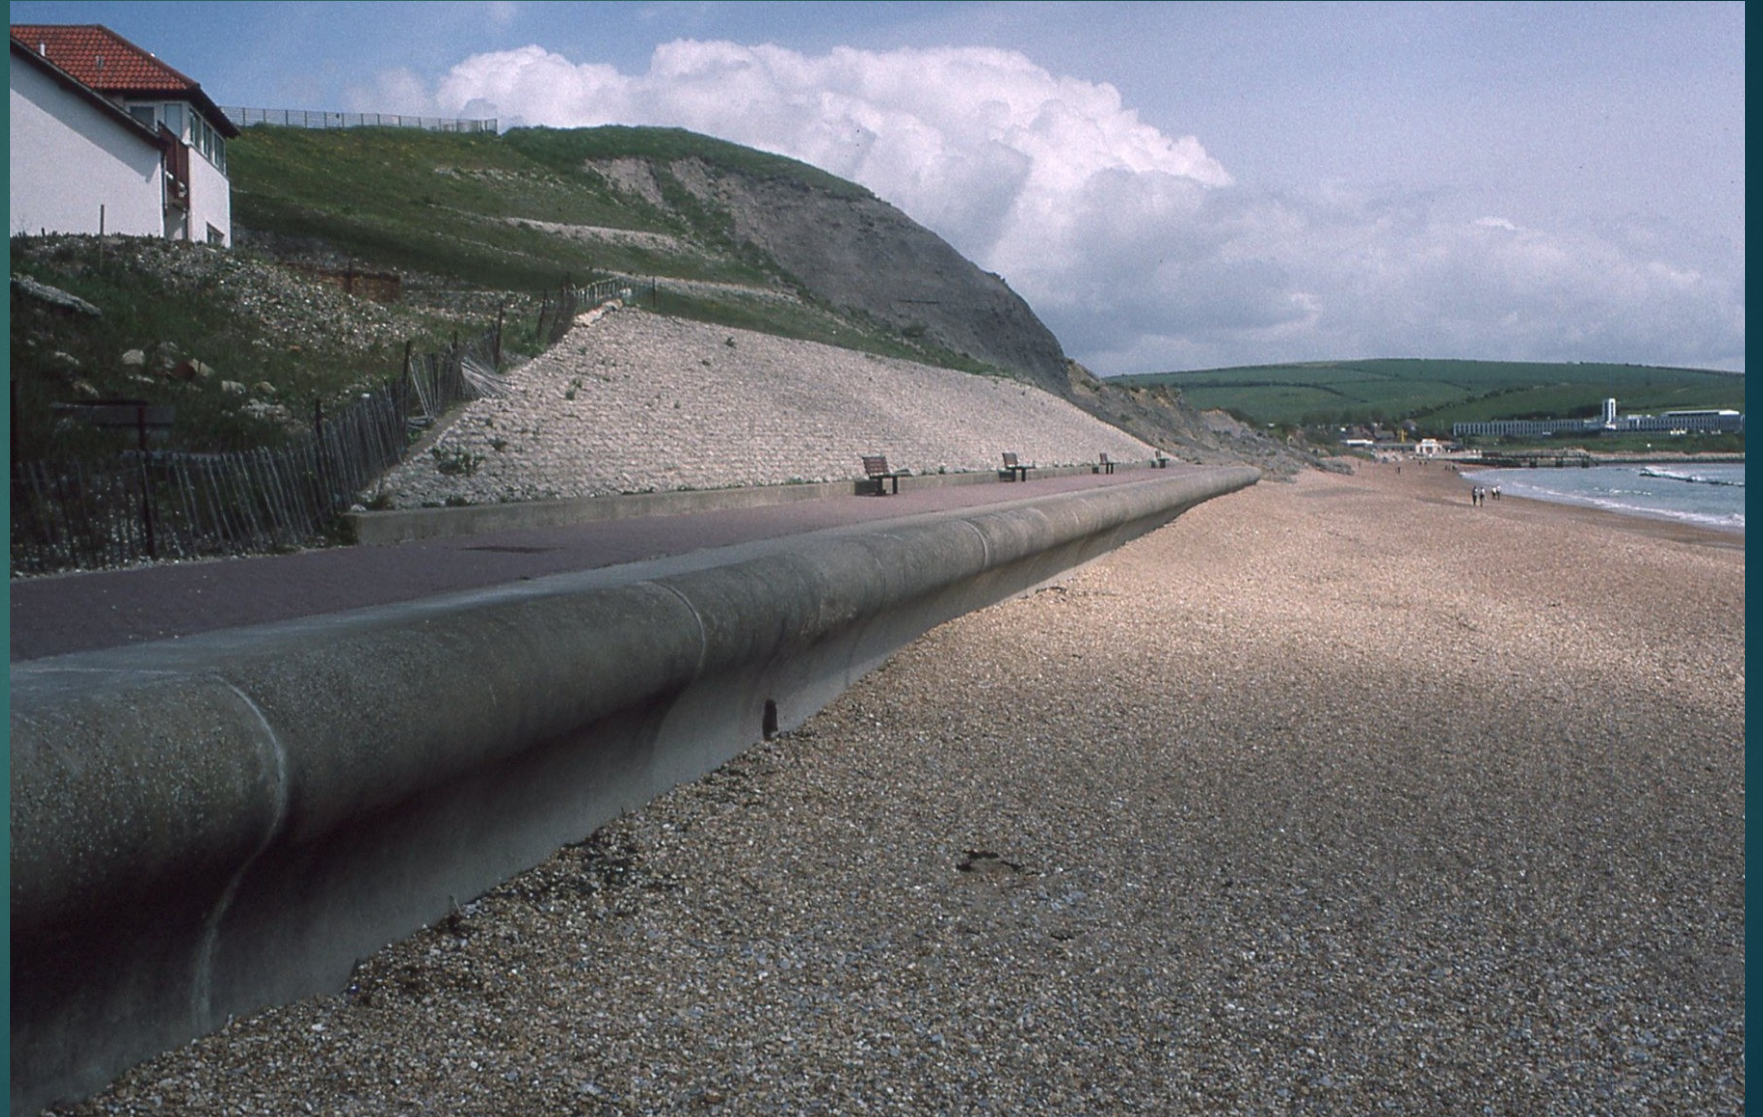
1983-4 defences cost c. £400,000. This view taken in 1996. The beach had built up due to the beach replenishment scheme along Preston Beach Road.

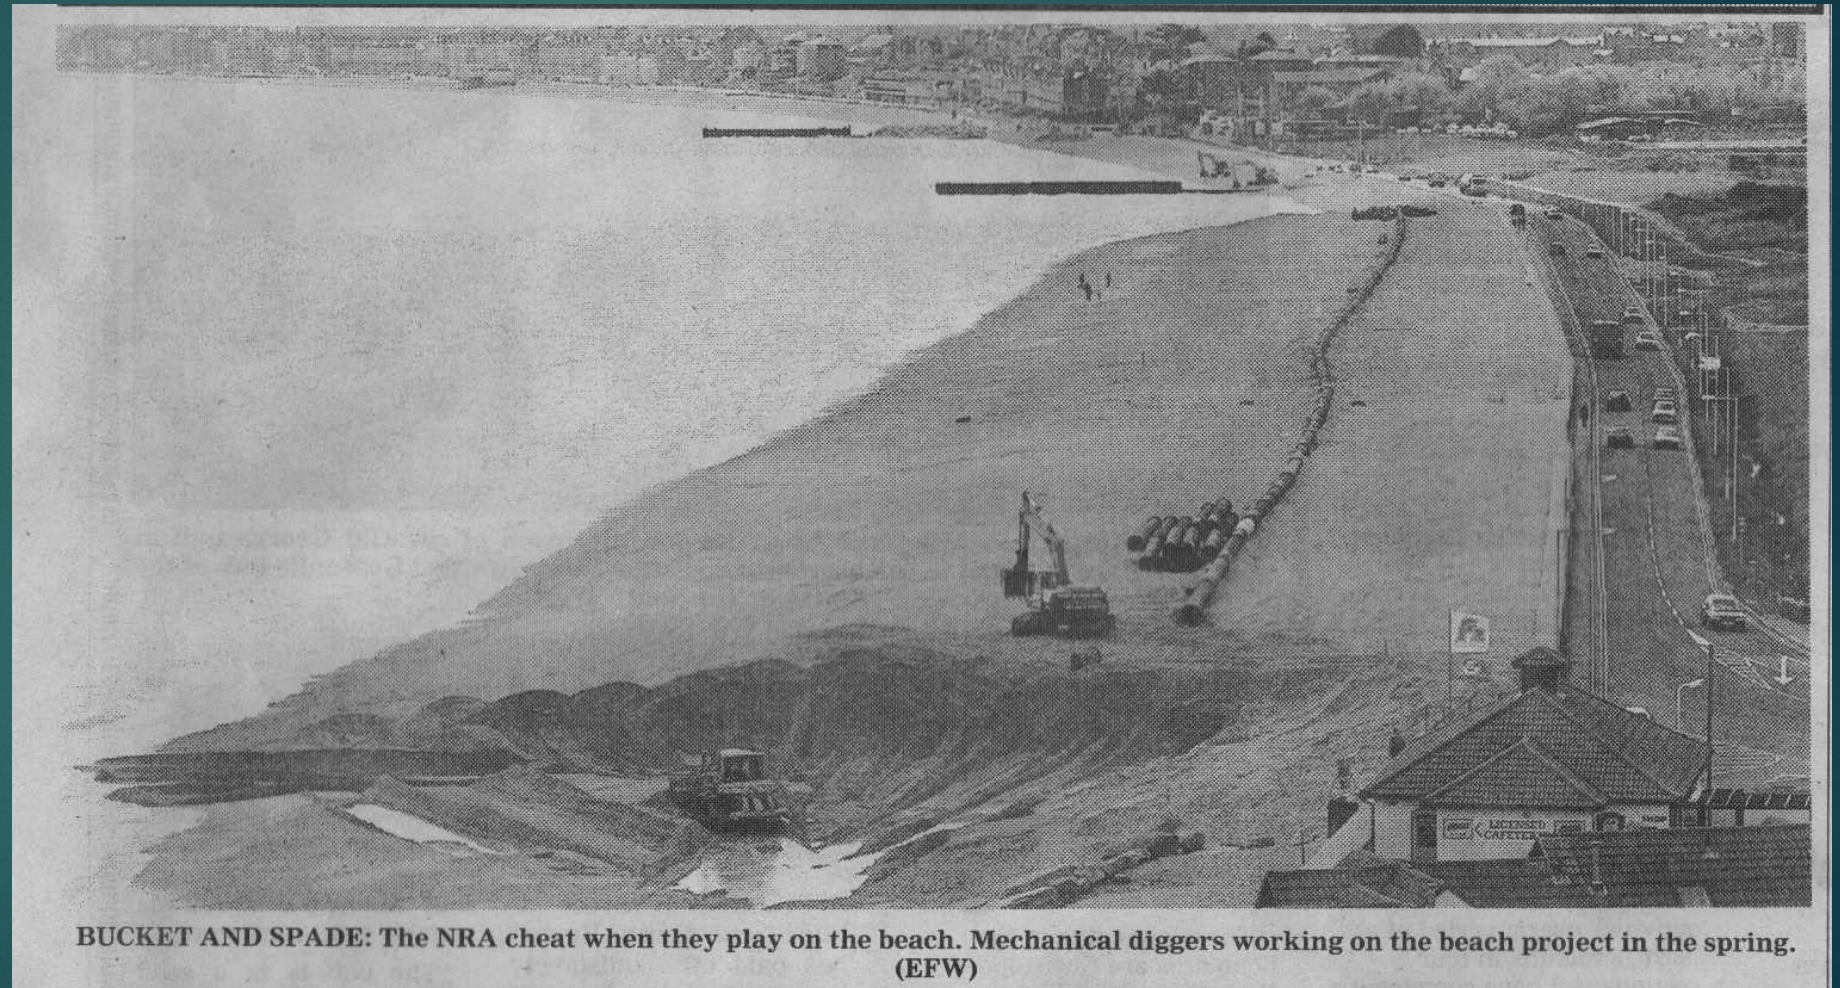
Beach
replenishment
work 1995.
214,000 cubic
metres of shingle
derived from
Needles area off
the Isle of Wight
borrow area off
the Isle of Wight.

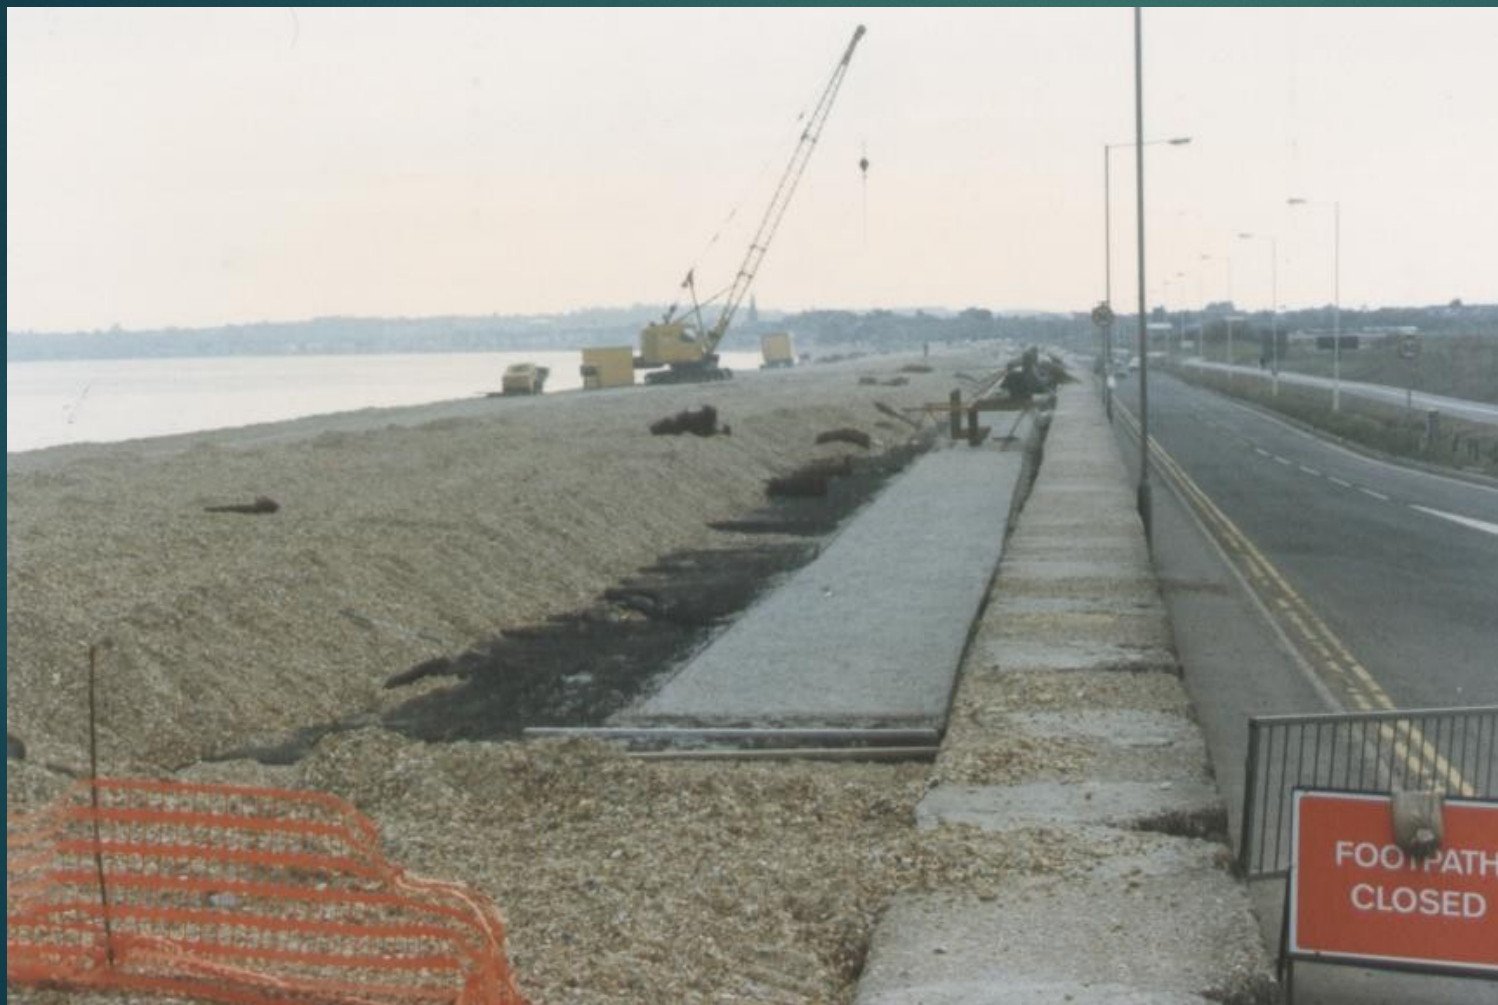
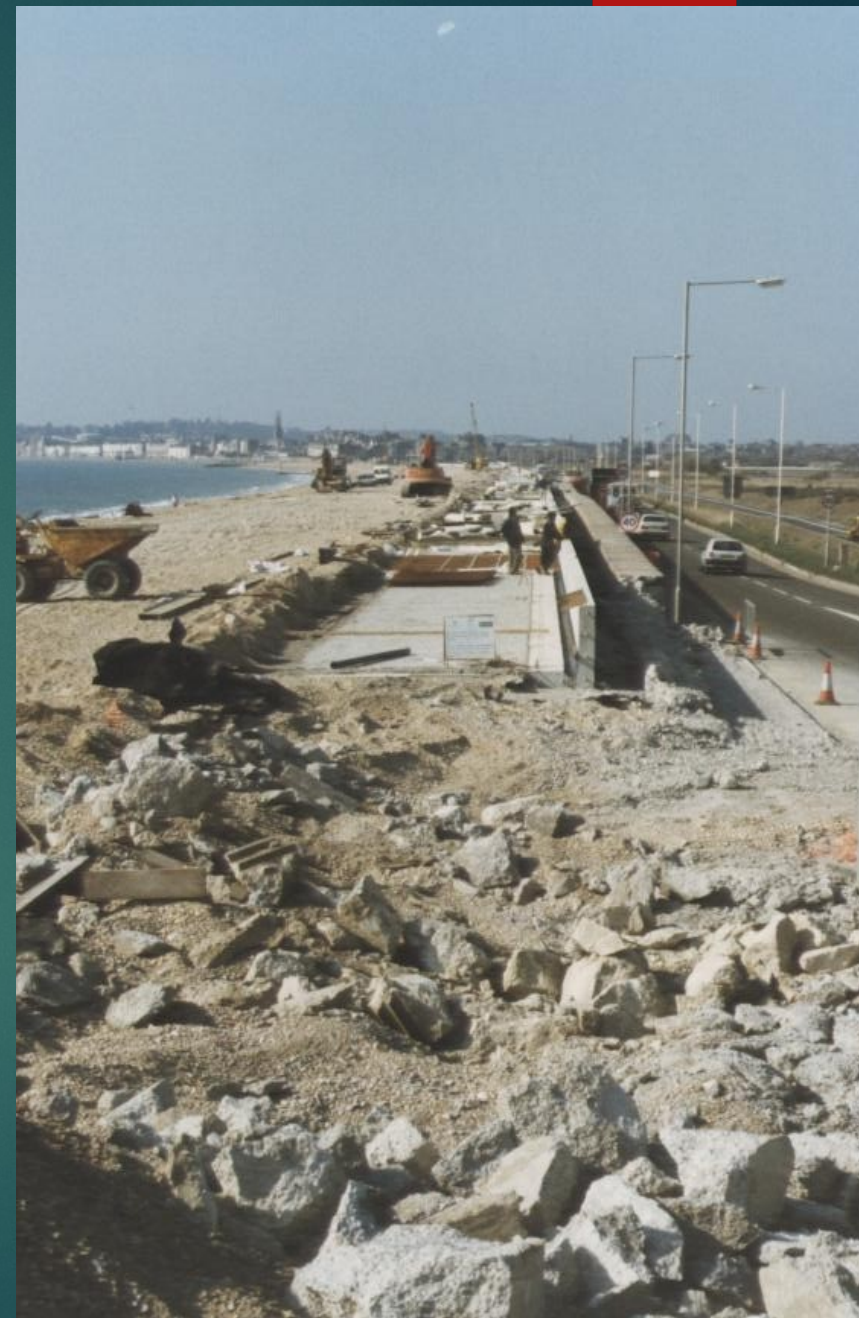
New sea wall being built,
cost around £6 million.

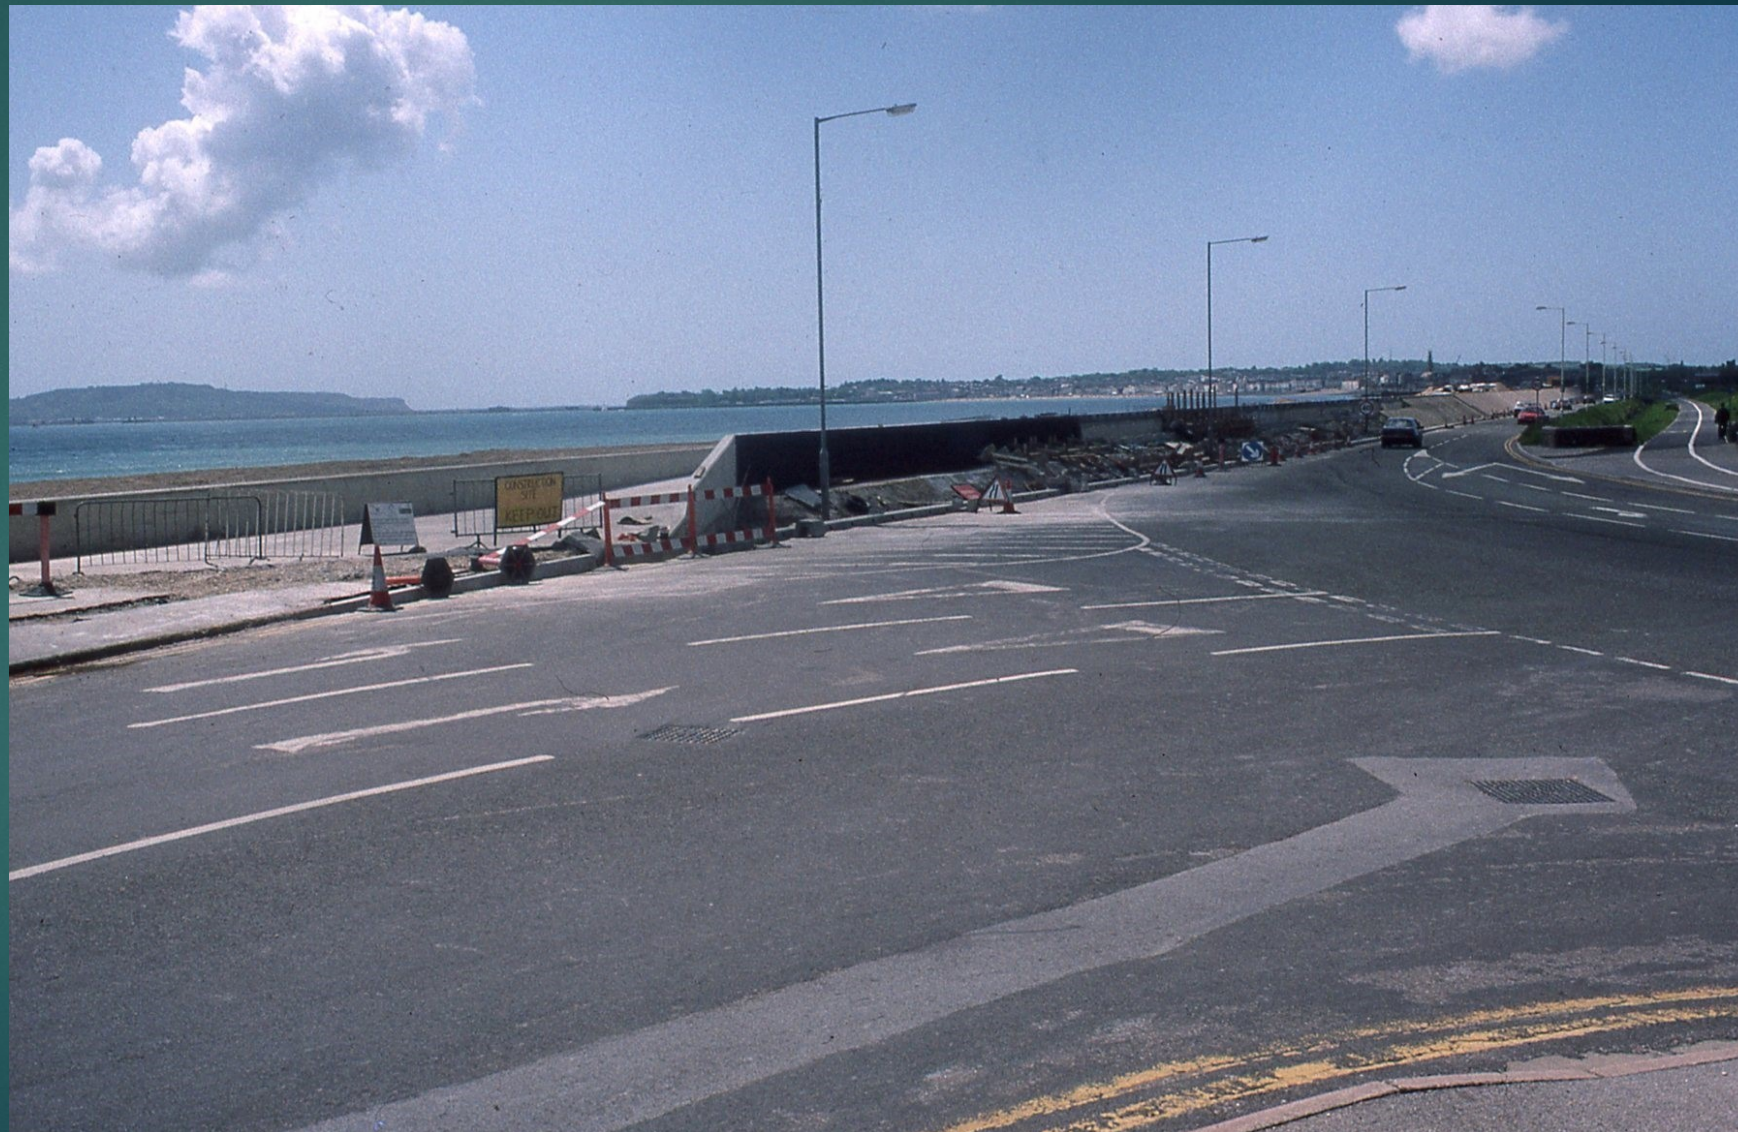
View taken
24.7.1996,
construction nearly
complete.

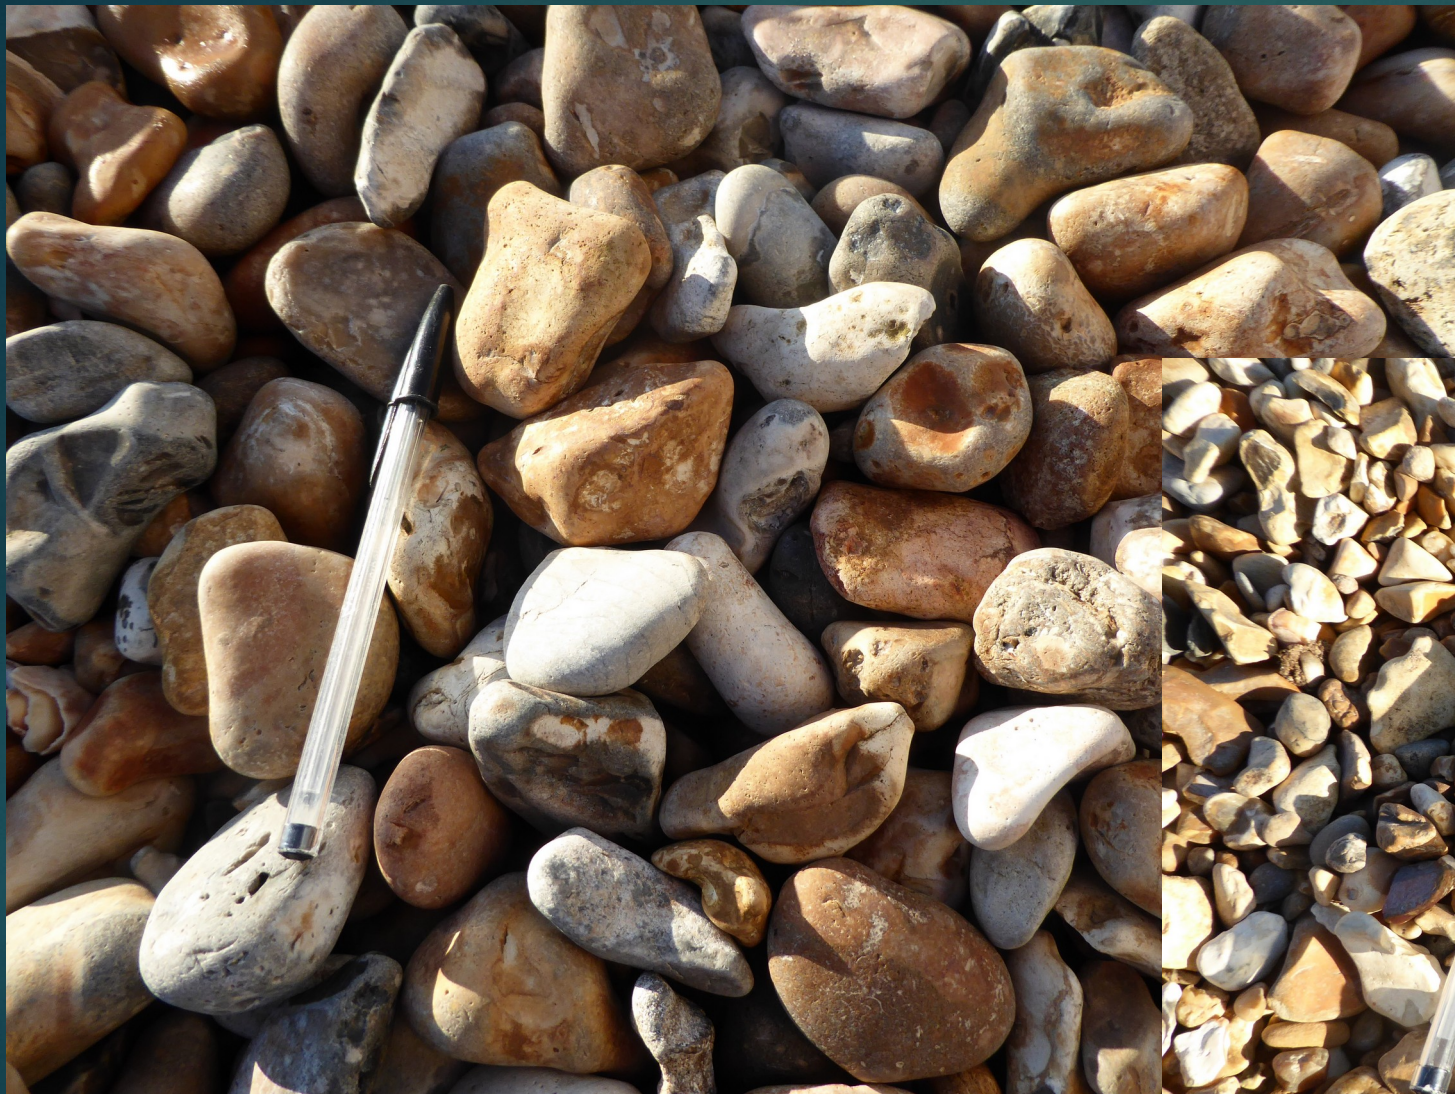
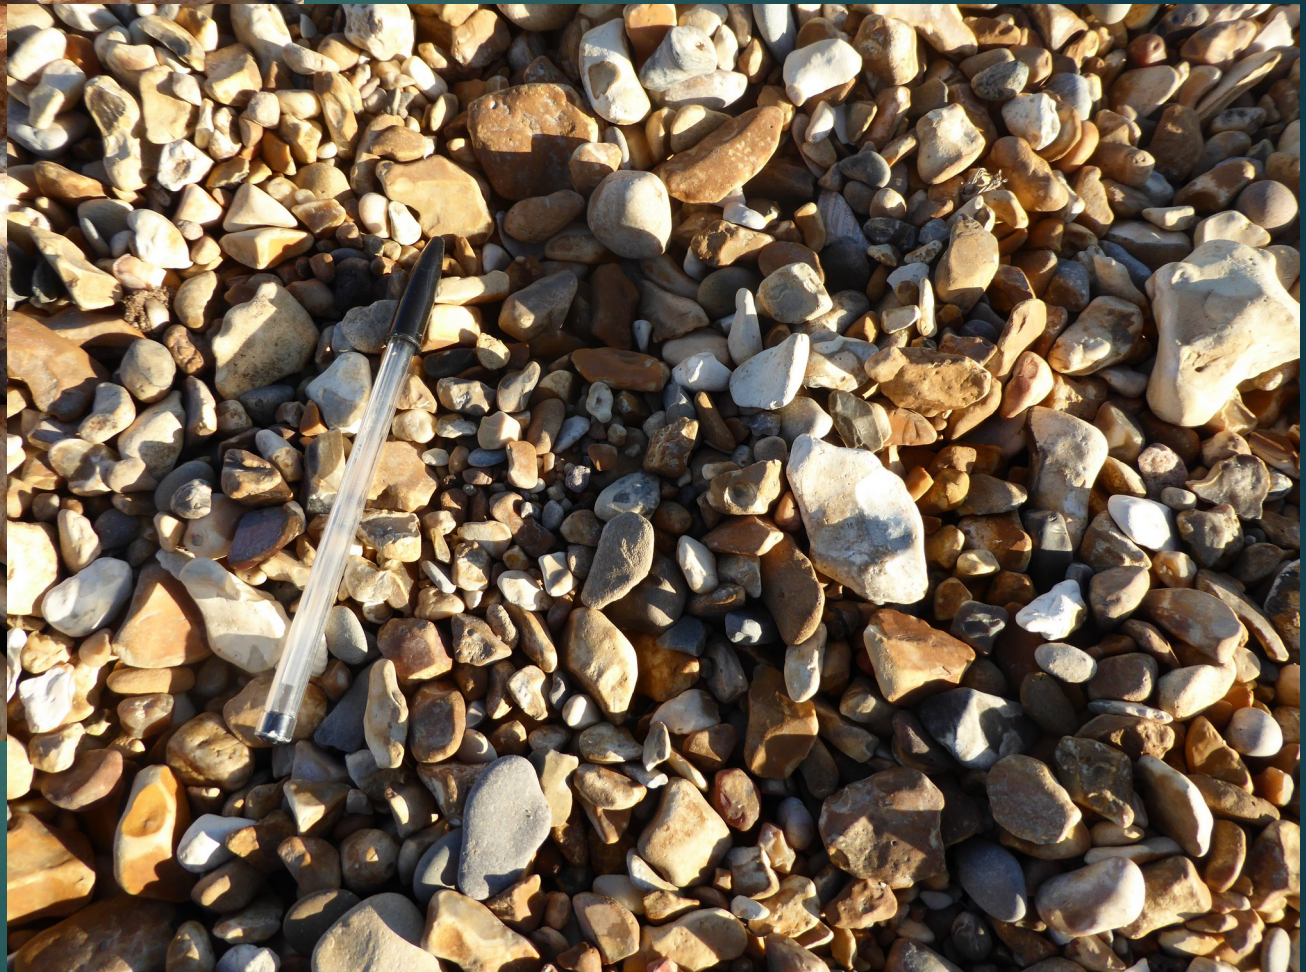
The wrong kind of shingle,
Greenhill, above, and Preston
Beach Road, right.

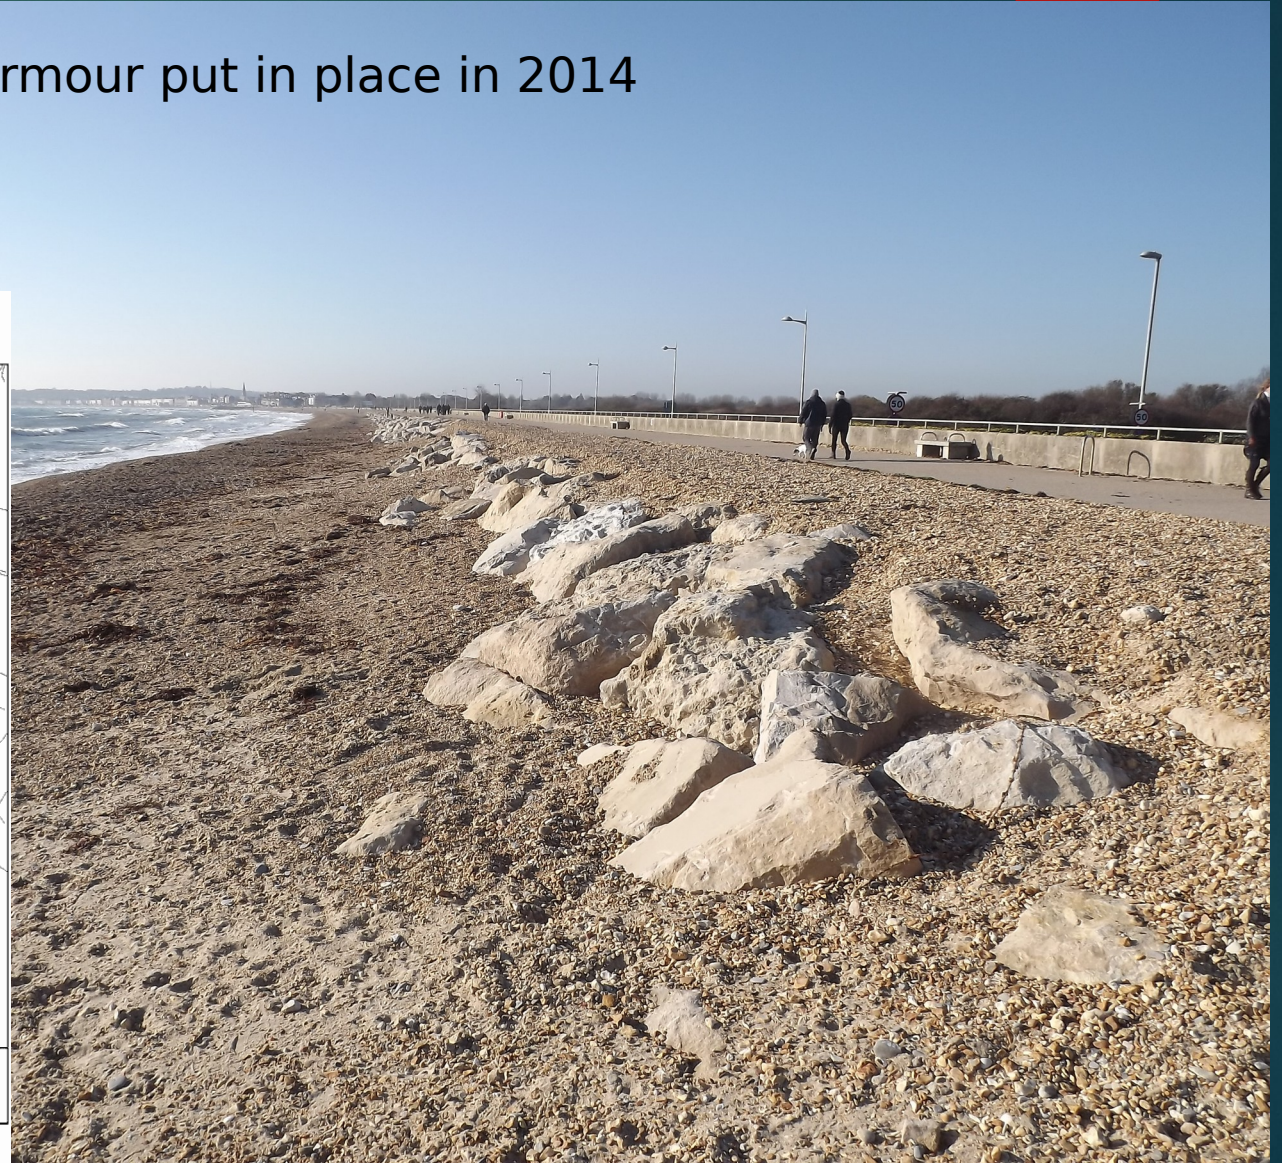
View taken on 18.11.18
following strong easterly
winds and synoptic chart
for 17.11.18.

Rock armour put in place in 2014

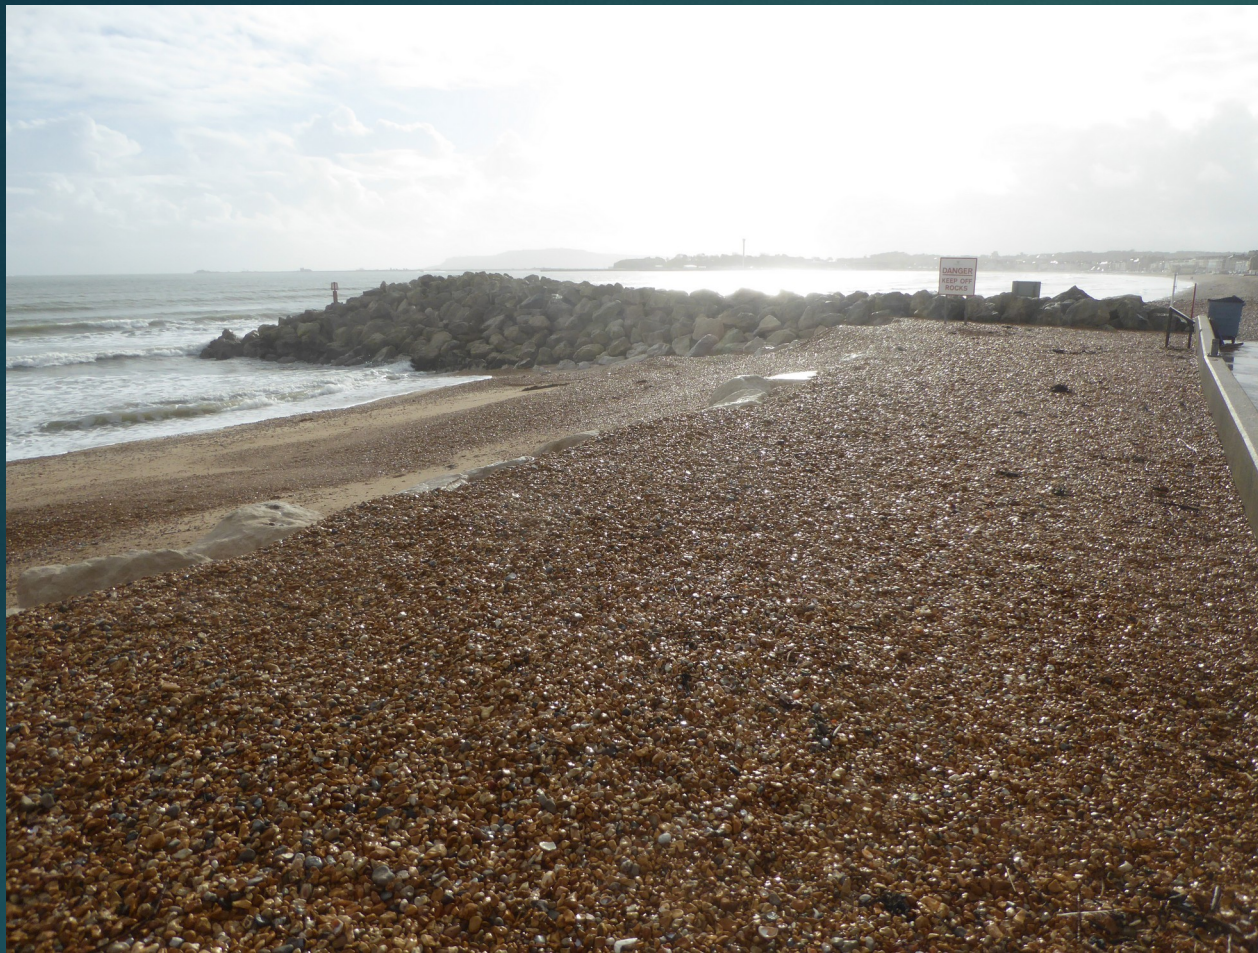
6,200 tons of Portland Stone.

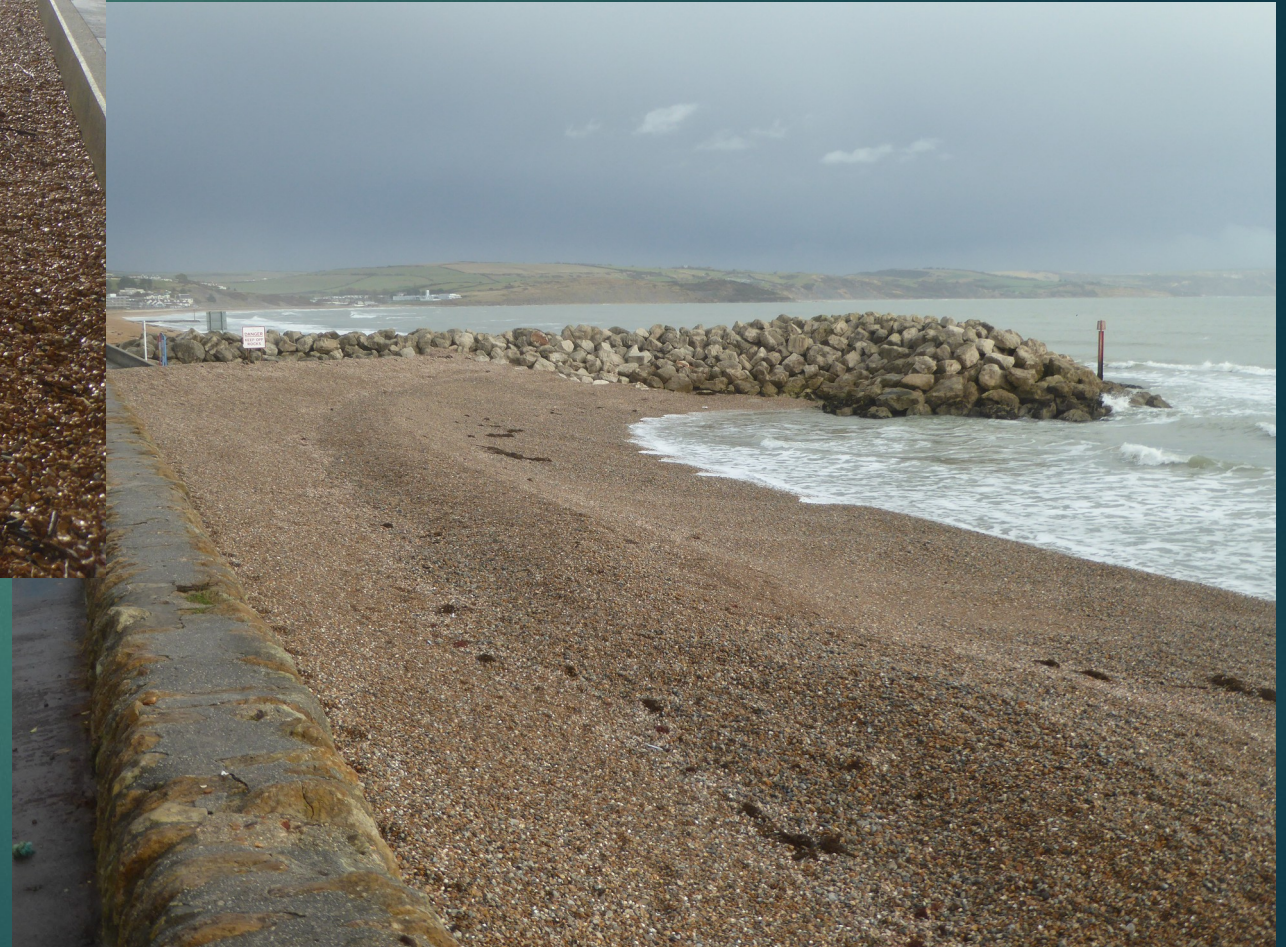
The groyne at Greenhill designed to stop shingle moving towards Weymouth. Why didn't they put a groyne at Overcombe?
